the **play inspection** company

Annual Inspection

Lichfield District Council

Elford Jubilee Memorial Playground

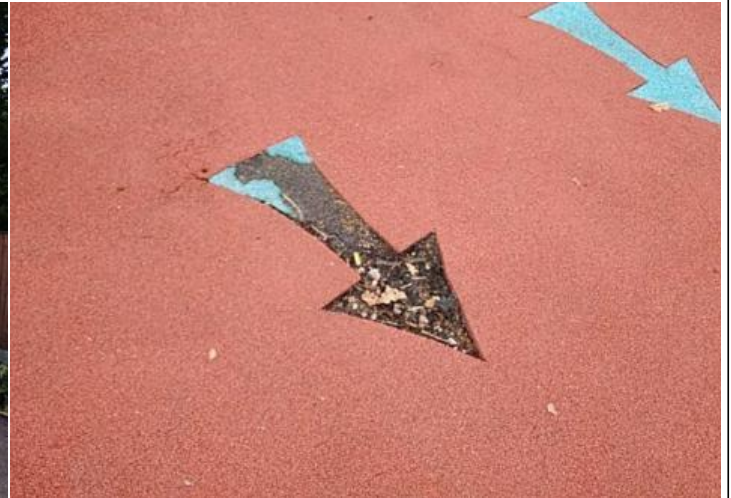
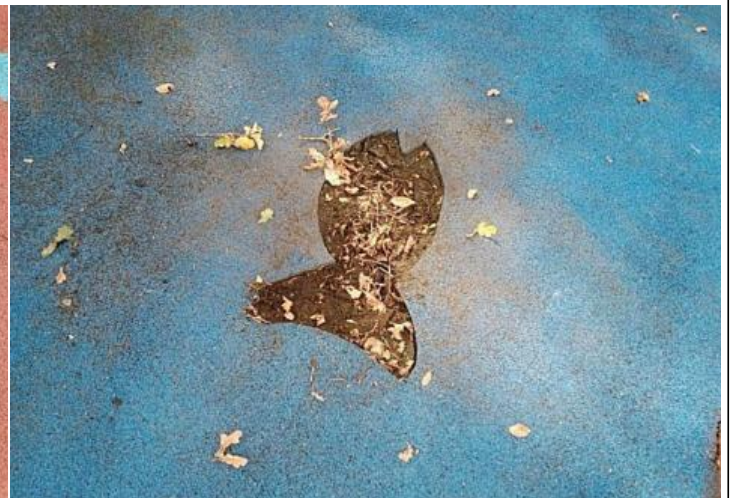
Finding: There is moderate damage to the surface

Action: Repair the damaged areas of surfacing

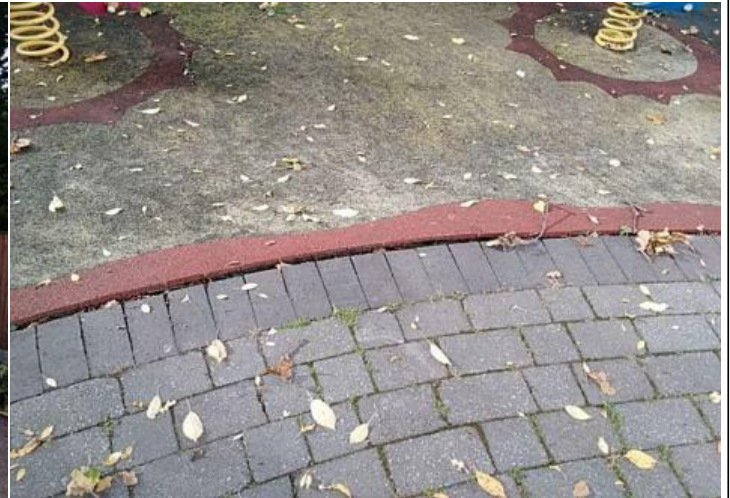
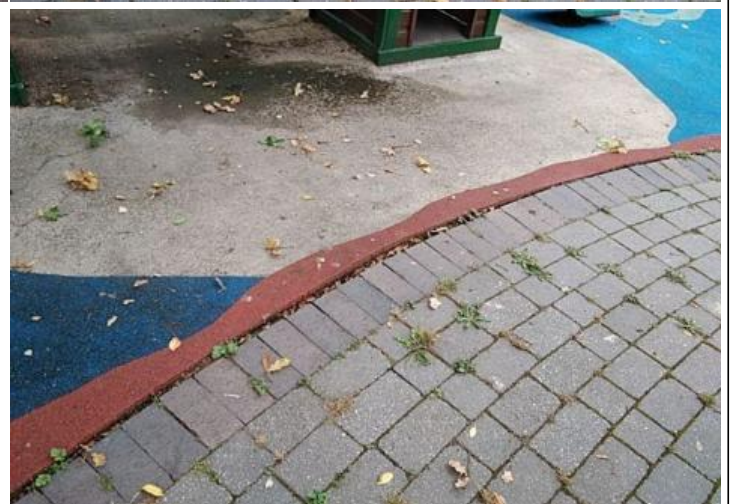
Finding: The surface is lifting at the edges and creating trip points

Action: Repair perimeter of surfacing to remove trip points

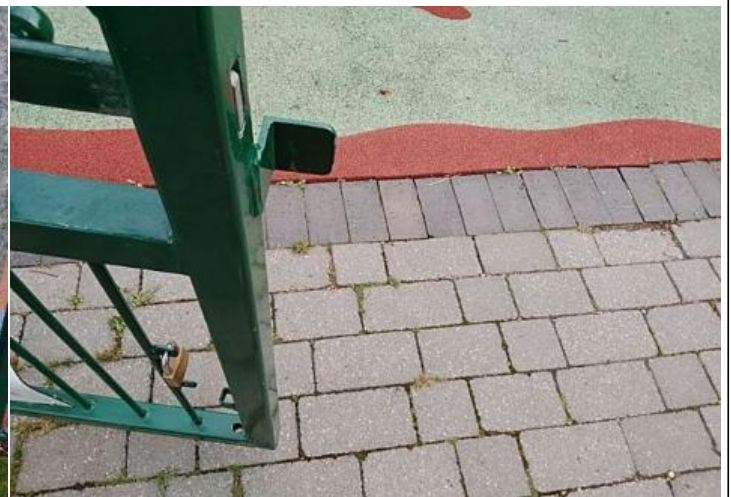
Finding: The rubber buffer is missing from the latch plate

Action: Replace rubber buffer

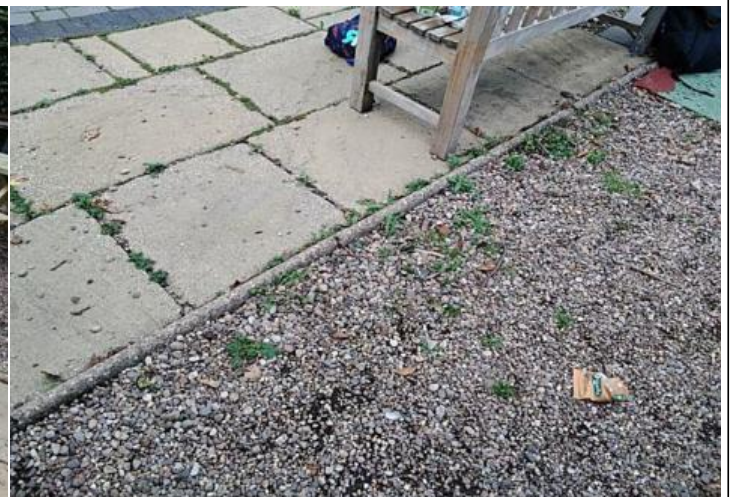
Finding: There are trip hazards at the edges of the surface

Action: Reinstate surrounding surface levels to remove the trip points

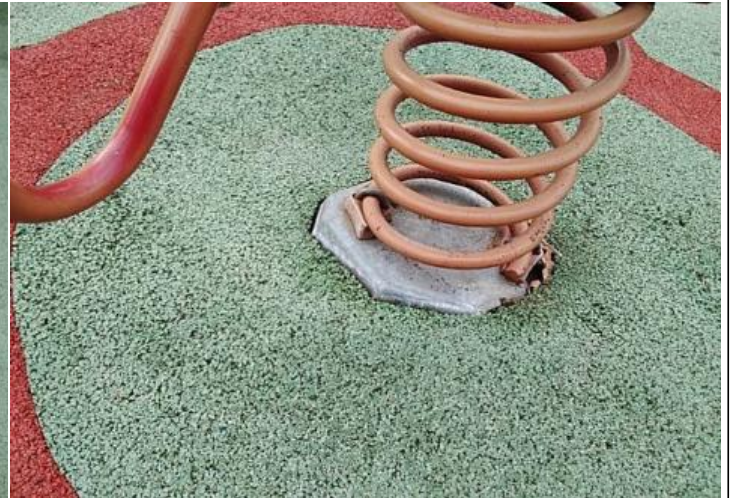
Finding: The spring clamps are loose

Action: Tighten all loose fixings

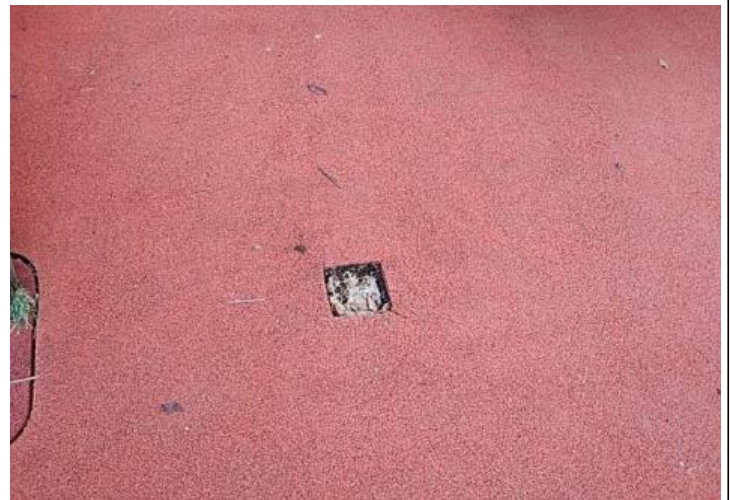
Finding: The surfacing is severely damaged exposing the concrete underneath

Action: Repair damaged areas of surfacing

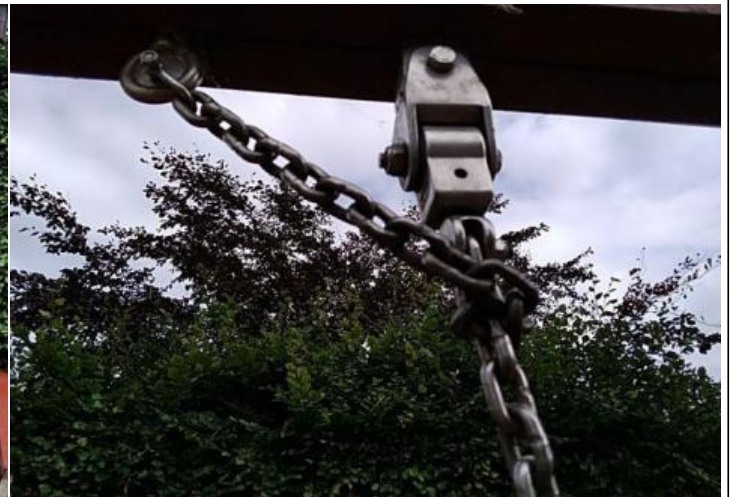
Finding: There is/are several inserts missing

Action: Replace missing inserts

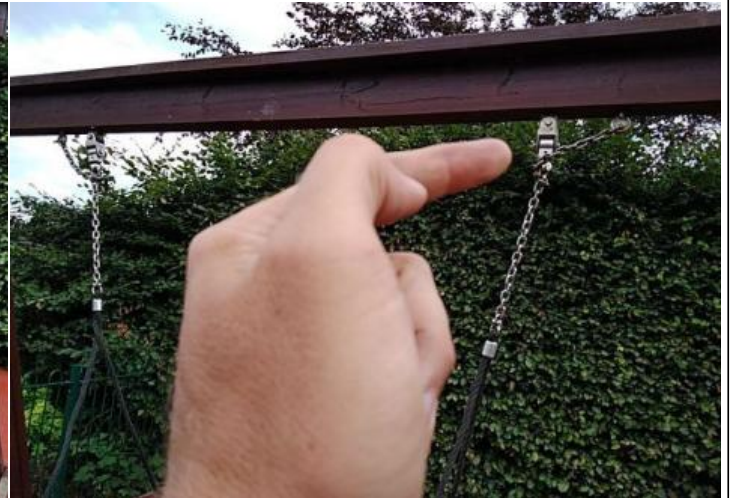
Finding: A number of fixing(s) have worked loose

Action: Secure all loose fixings

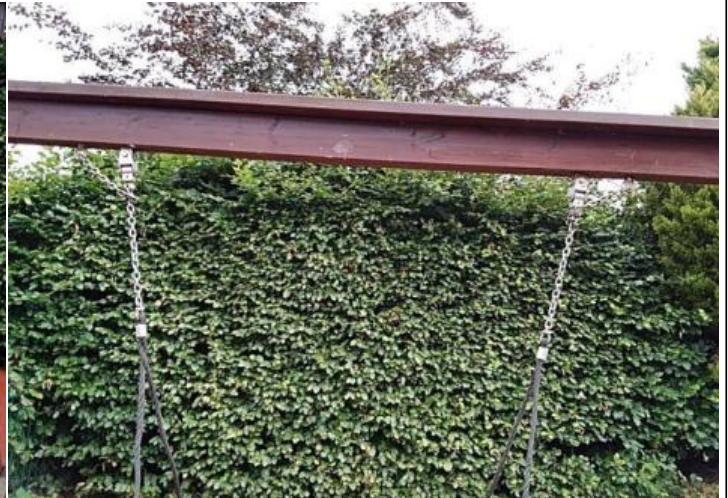
Finding: The bushes are showing signs of wear

Action: Monitor for any further deterioration and replace as required

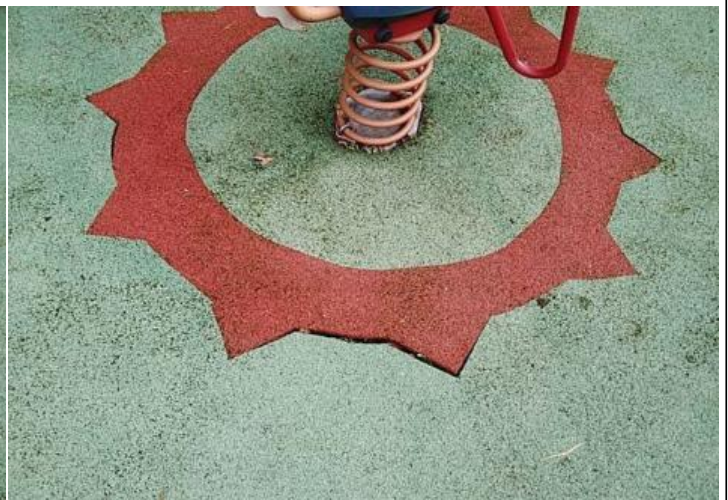
Finding: There are gaps opening between the surfacing and the edging surround or between the joints in the surfacing

Action: Monitor for any further deterioration and repair as required

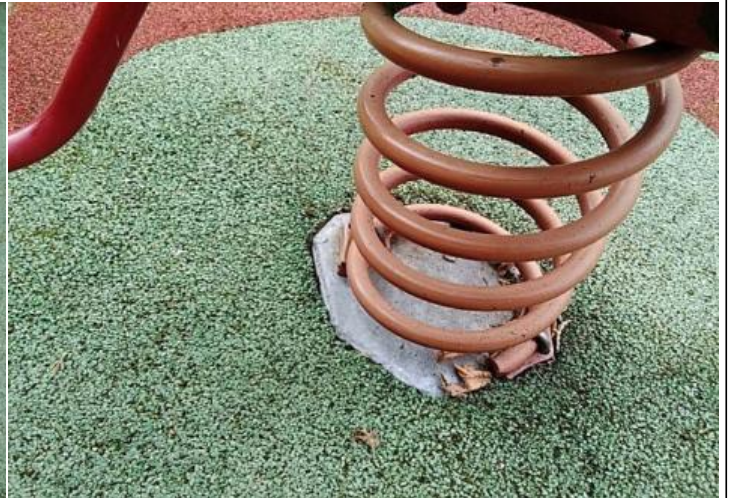
Finding: The spring clamps are loose

Action: Tighten all loose fixings

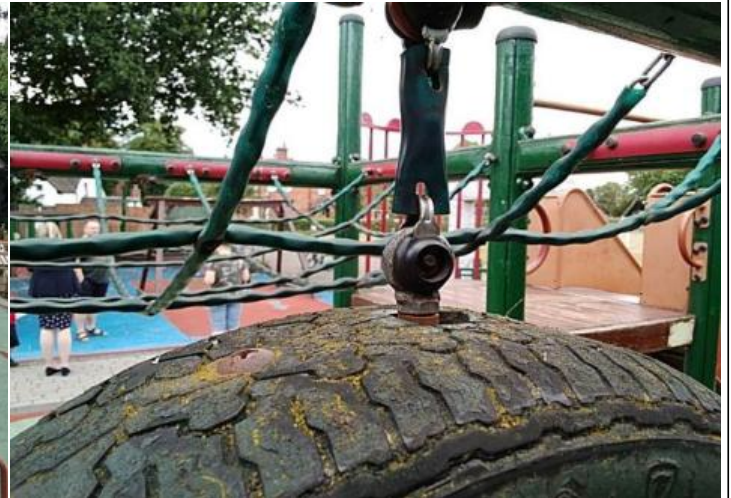
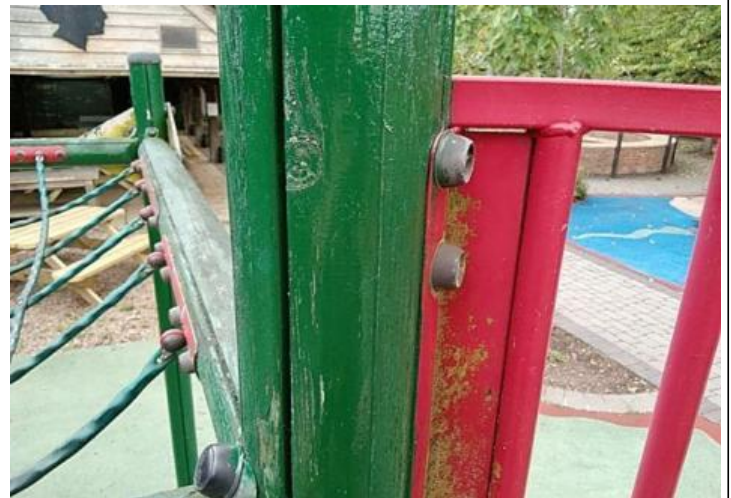
Finding: There is/are bolt cap covers missing or damaged on the item

Action: Replace missing or damaged bolt cap covers

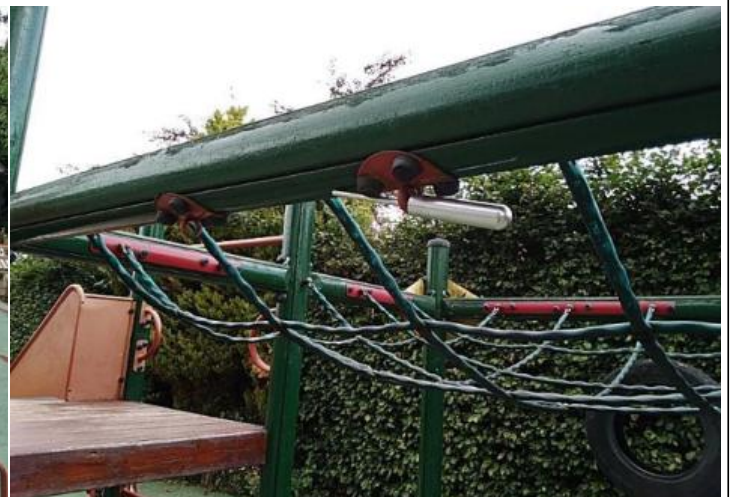
Finding: There is/are finger entrapment/s in the redundant lugs and the item fails to meet the requirements of BS EN 1176 Part 1 4.2.7.6 Entrapment of fingers

Action: Replace component or remove lugs

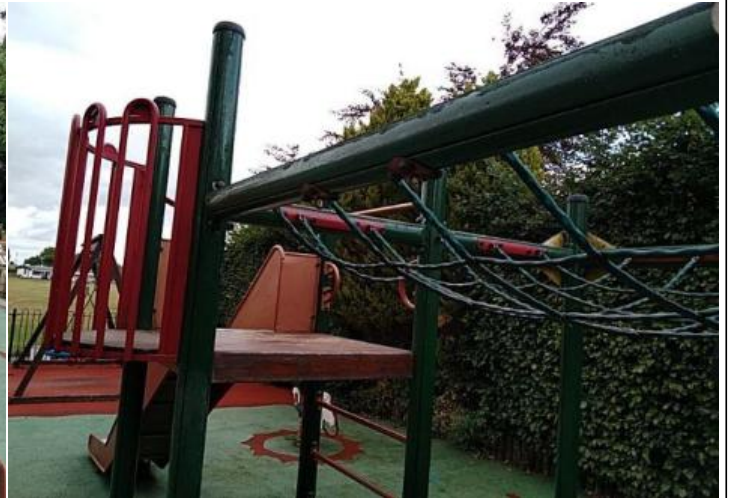
Finding: The item has missing component(s)

Action: Consider replacing missing components

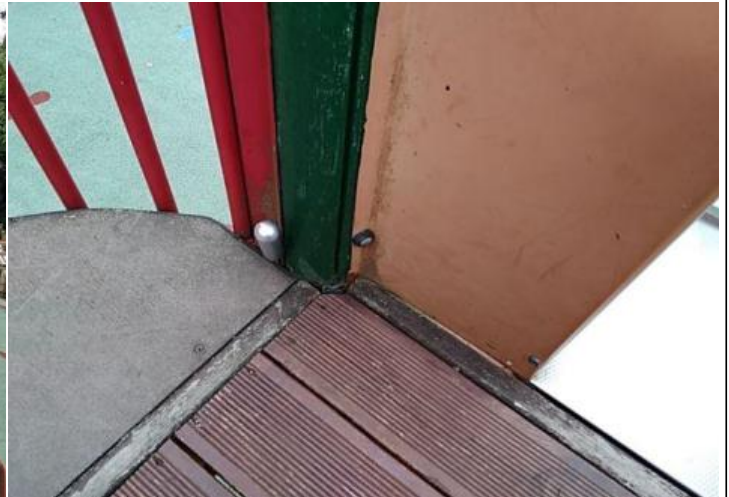
Finding: There is/are finger entrapment/s in the platform and the item fails to meet the requirements of BS EN 1176 Part 1 4.2.7.6 Entrapment of fingers

Action: Monitor - No remedial work recommended

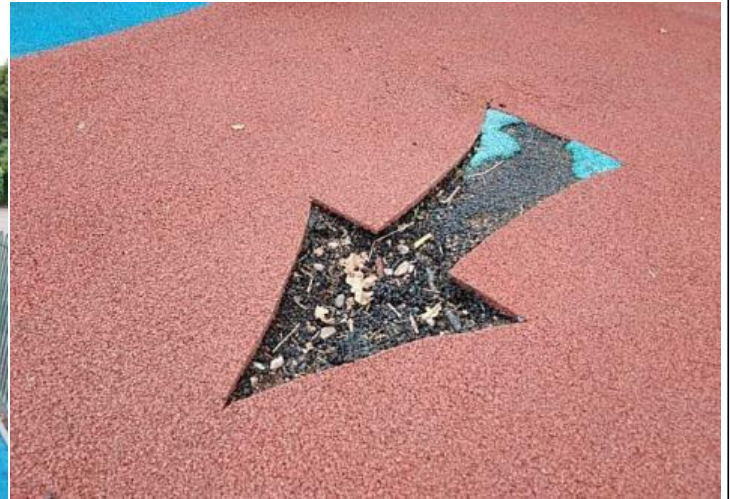
Finding: The surface is lifting at the edges and creating trip points

Action: Repair perimeter of surfacing to remove trip points

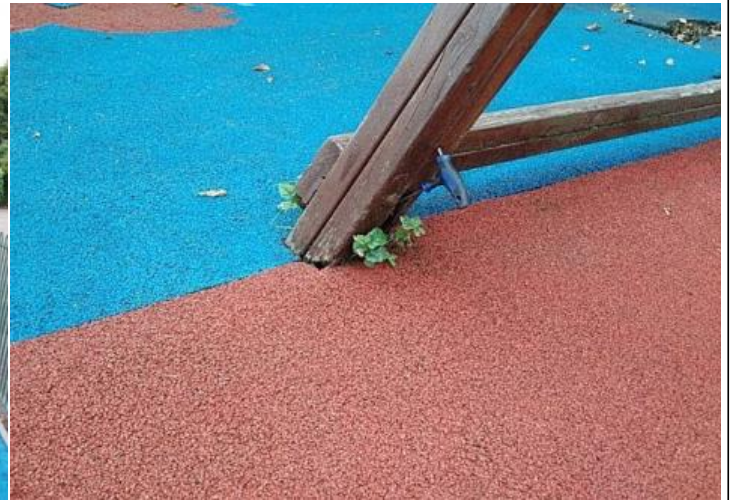
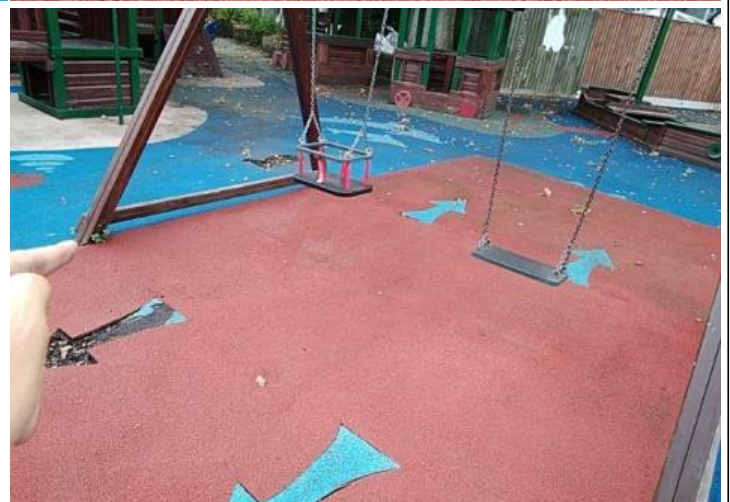
Finding: There are areas or parts of the timber on the structure that have rotted

Action: Replace all affected timbers

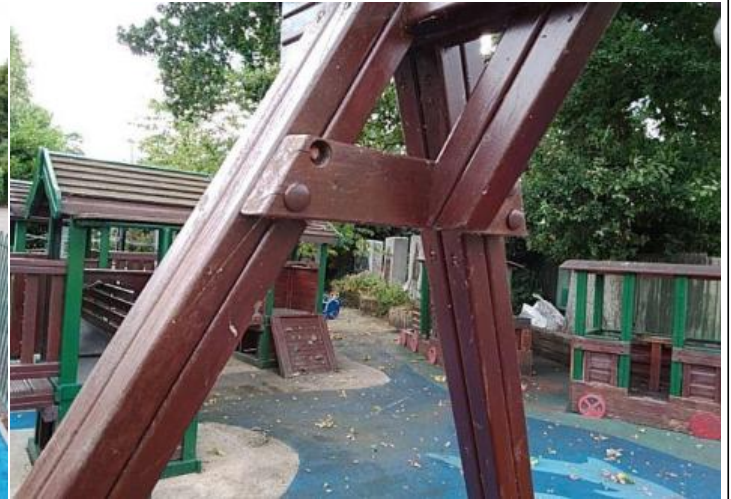
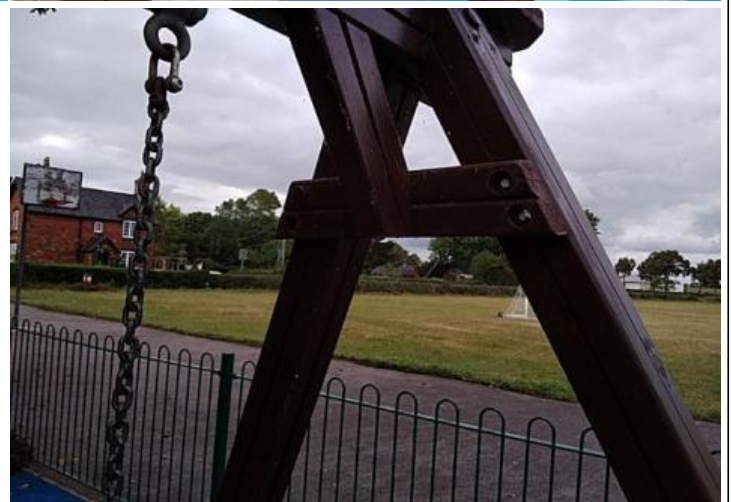
Finding: There is/are bolt cap covers missing or damaged on the item

Action: Replace missing or damaged bolt cap covers

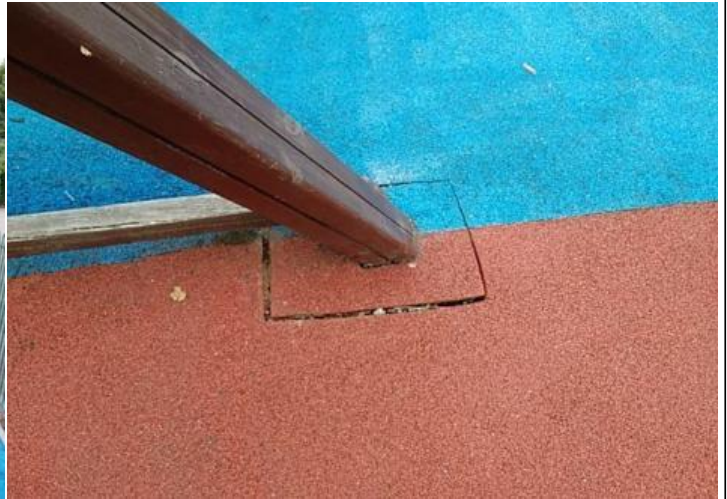
Finding: There are gaps opening between the surfacing and the edging surround or between the joints in the surfacing
Action: Monitor for any further deterioration and repair as required

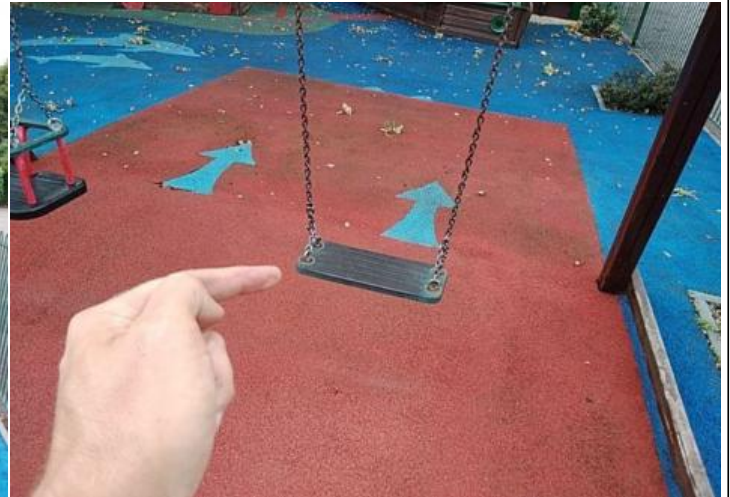
Finding: The swing seat connectors are loose

Action: Tighten to secure

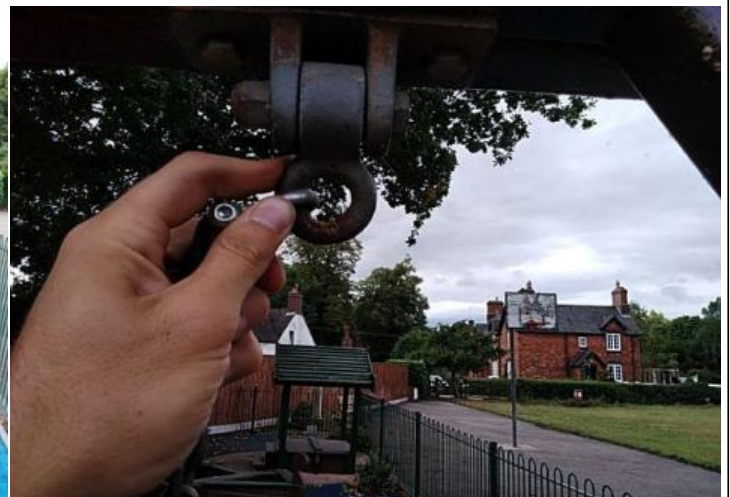
Finding: There is some wear to the lugs

Action: Monitor for any further deterioration and replace when 40% worn

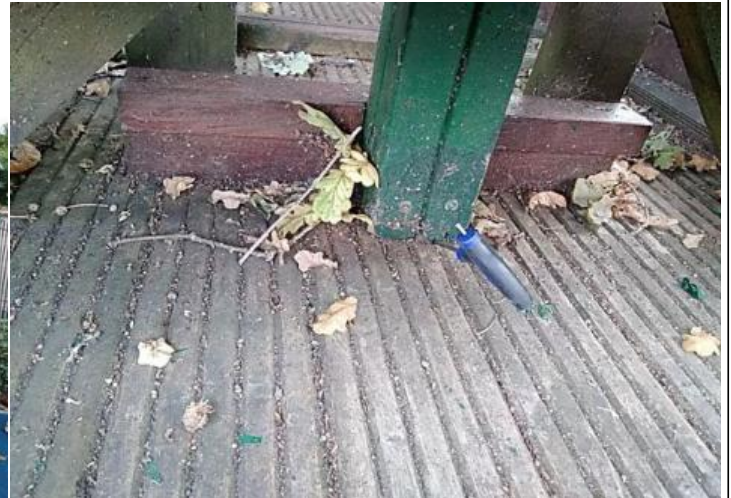
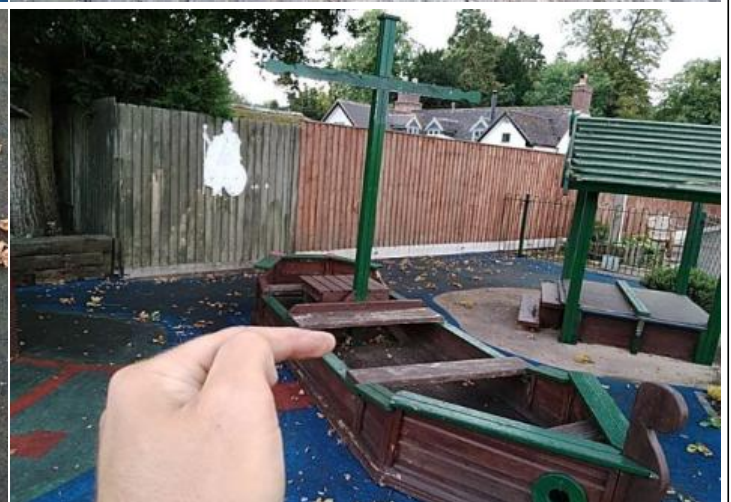
Finding: There is some evidence of rot in the timber

Action: Monitor for any further deterioration and replace as required

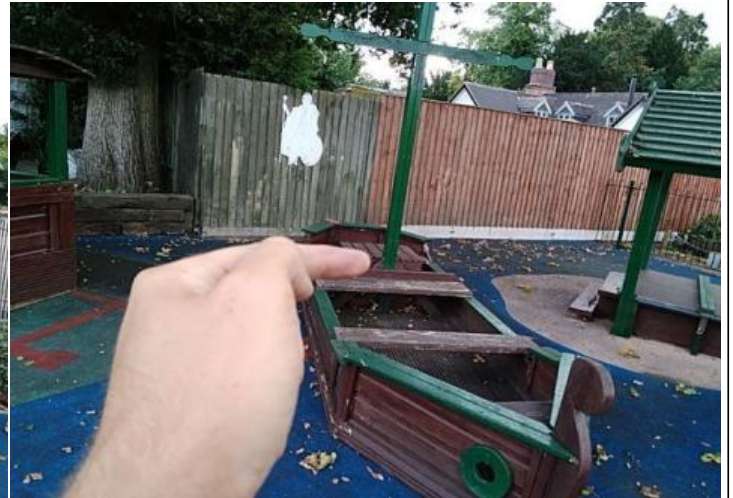
Finding: The item is slightly loose in its foundations

Action: Monitor for any further deterioration and repair as required

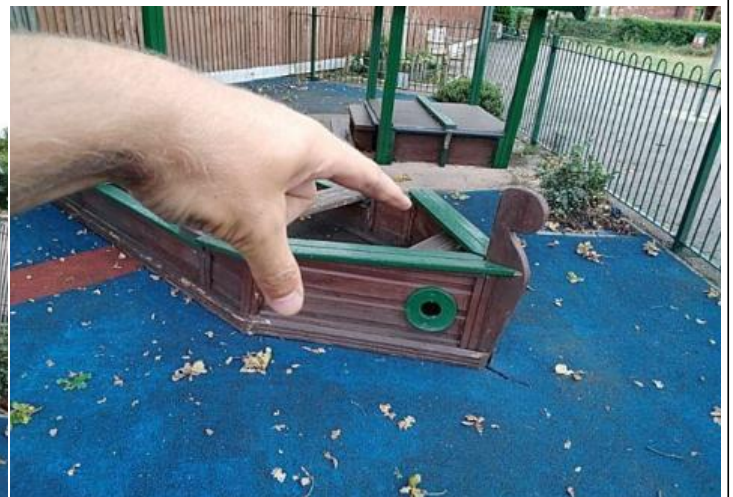
Finding: A number of fixing(s) have worked loose

Action: Secure all loose fixings

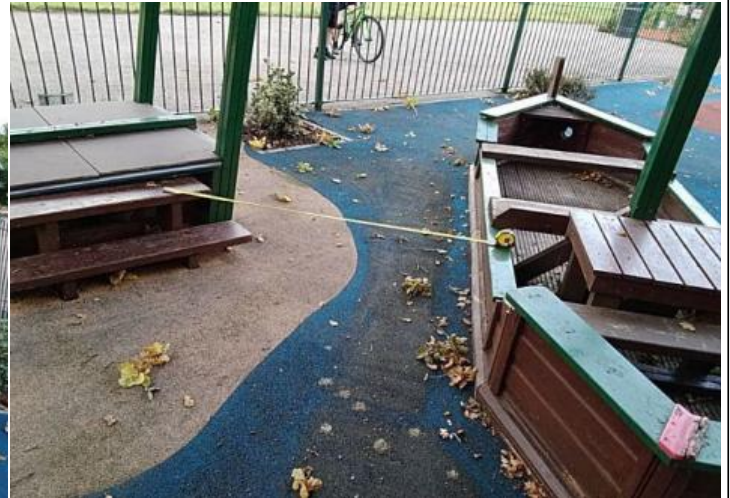
Finding: The shelter forms a hard object within the impact area of the equipment in contravention of the requirements of BS EN 1176 Part 1

Action: Monitor - No remedial work recommended

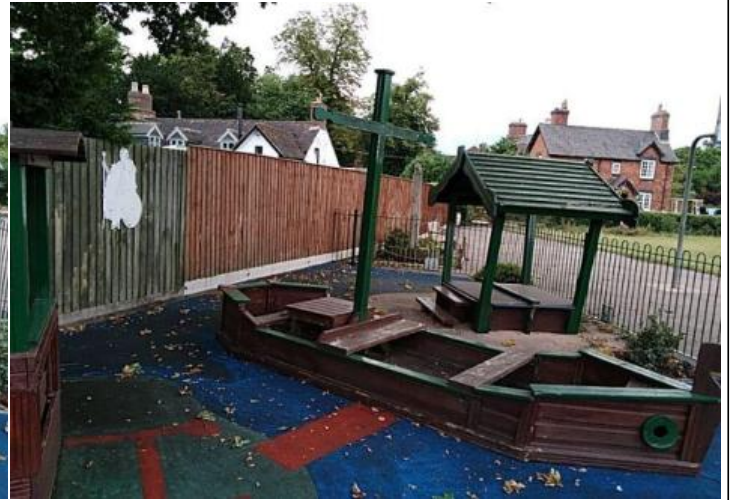
Finding: This item of equipment relies on a single post, or a line of posts, for stability and extra care needs to be taken with equipment of this nature to avoid the potential for catastrophic failure
Action: Ensure that regular detailed inspections are undertaken to assess for rot, corrosion and general stability

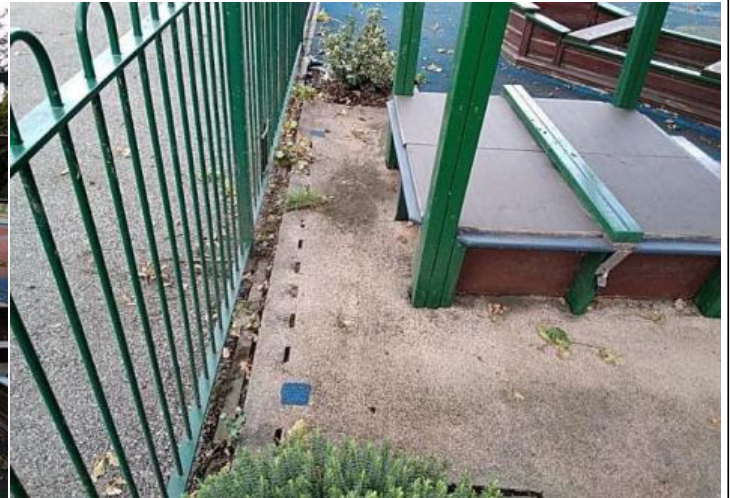
Finding: The fence forms a hard object within the impact area of the equipment in contravention of the requirements of BS EN 1176 Part 1

Action: Monitor - No remedial work recommended

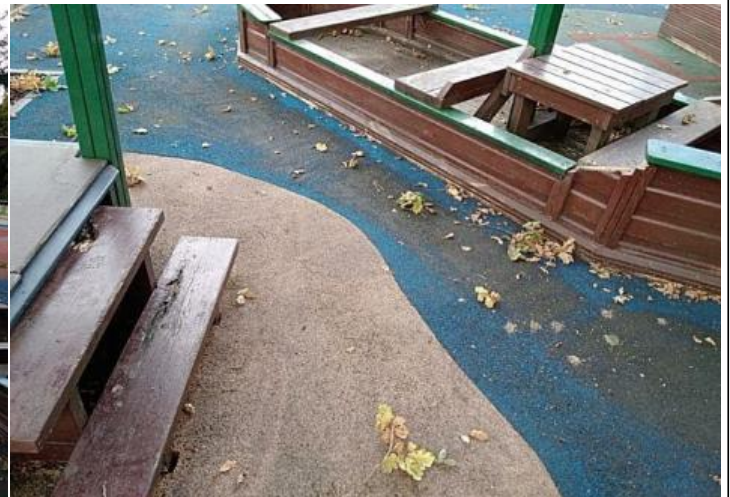
Finding: The boat forms a hard object within the impact area of the equipment in contravention of the requirements of BS EN 1176 Part 1

Action: Monitor - No remedial work recommended

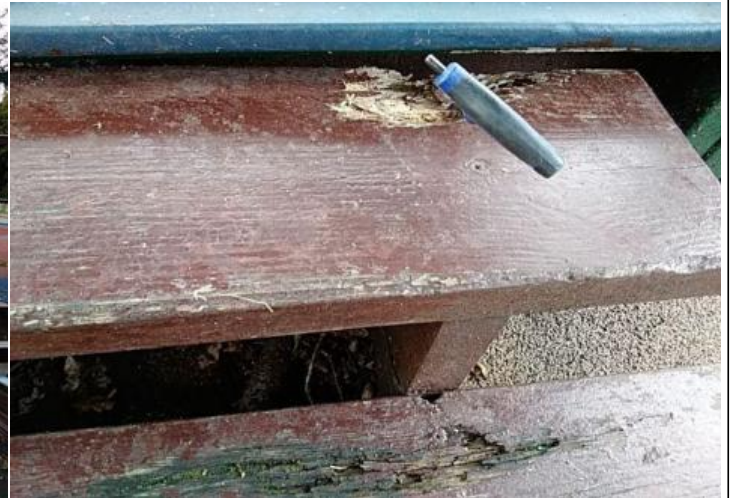
Finding: There are areas or parts of the timber on the structure that have rotted

Action: Replace all affected timbers

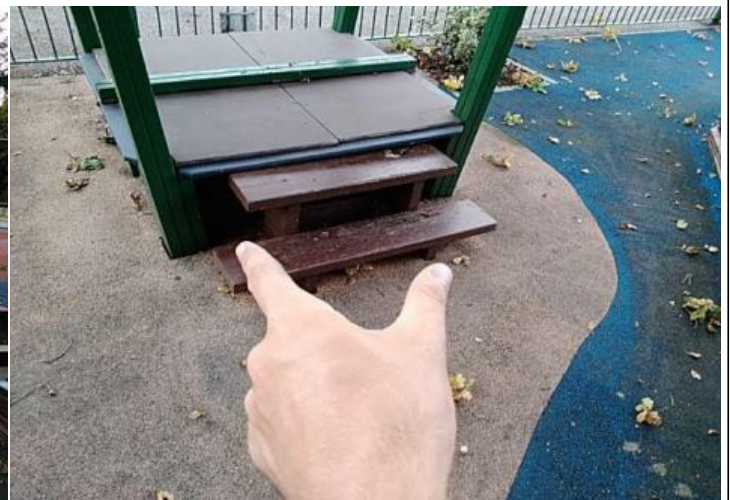
Finding: A number of fixing(s) have worked loose

Action: Secure all loose fixings

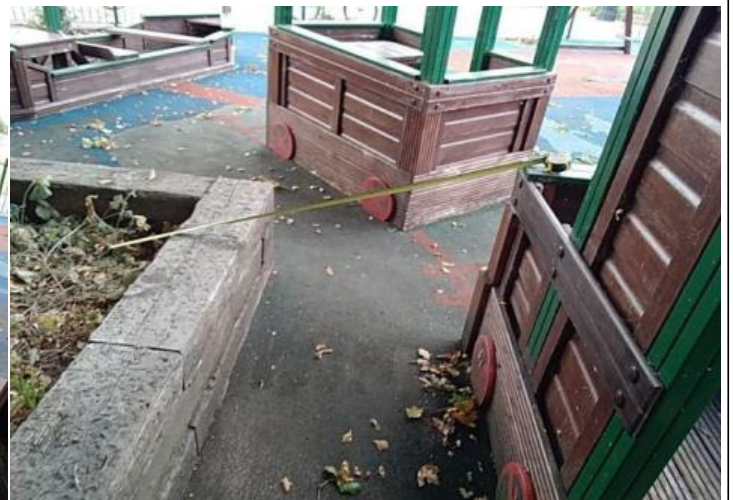
Finding: The sleepers form a hard object within the impact area of the equipment in contravention of the requirements of BS EN 1176 Part 1

Action: Monitor - No remedial work recommended

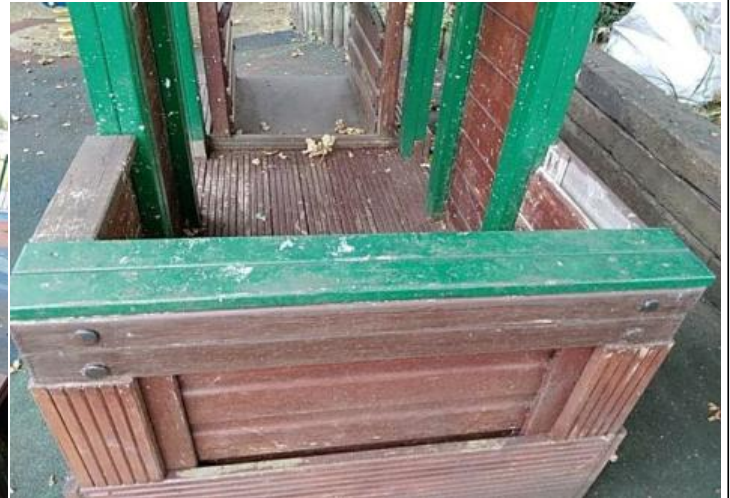
Finding: The design of the barriers encourages standing or sitting and fails the requirements of BS EN 1176
Action: Monitor - No remedial work recommended

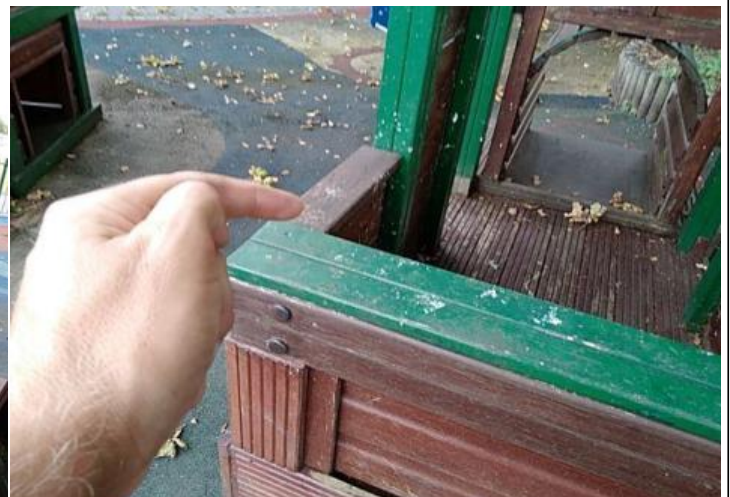
Finding: A number of fixing(s) have worked loose
Action: Secure all loose fixings

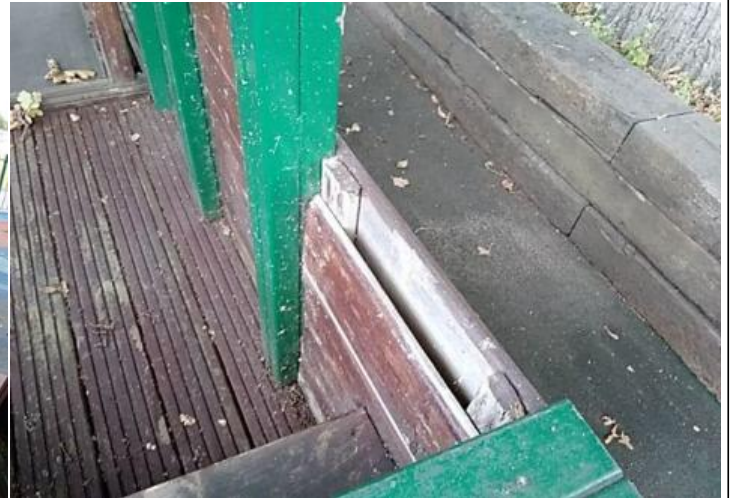
Finding: The item has missing component(s)

Action: Consider replacing missing components

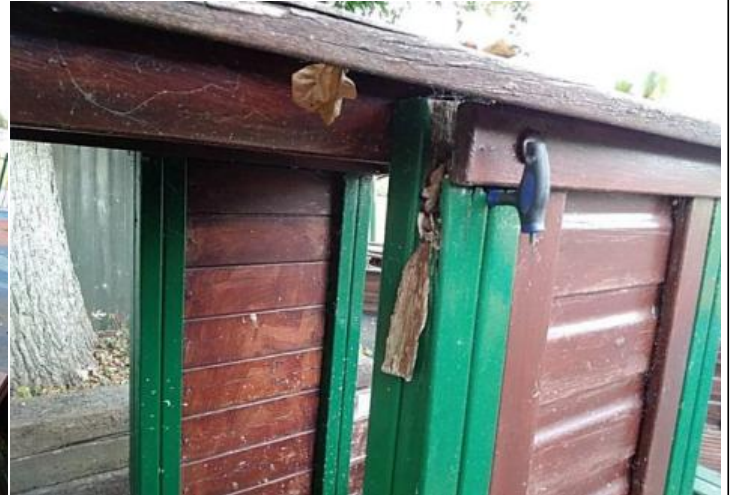
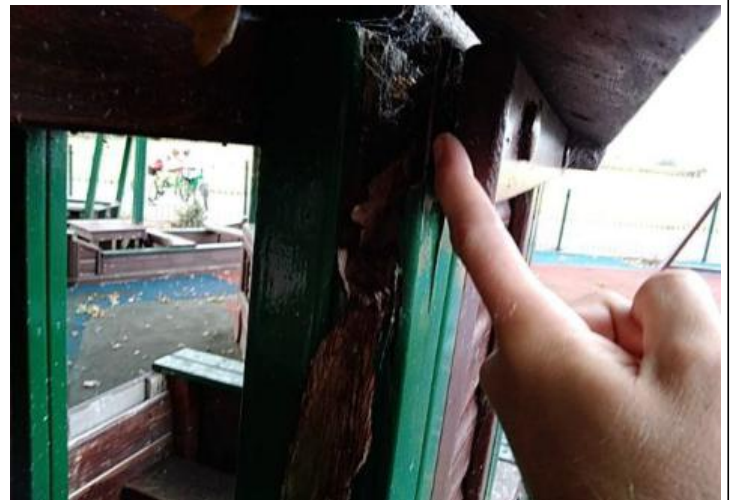
Finding: There are areas or parts of the timber on the structure that have rotted

Action: Replace all affected timbers

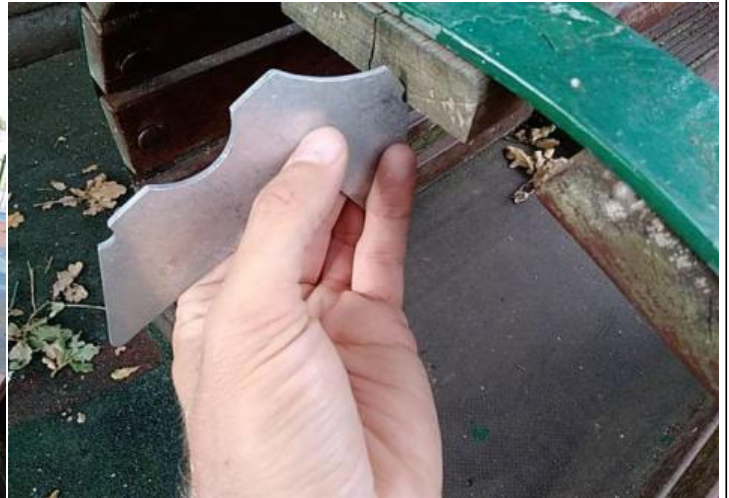
Finding: The item has exposed edges and corners with a radius of less than 3mm and fails the requirements of BS EN 1176
Action: Provide a 3mm radius to all exposed edges and corners

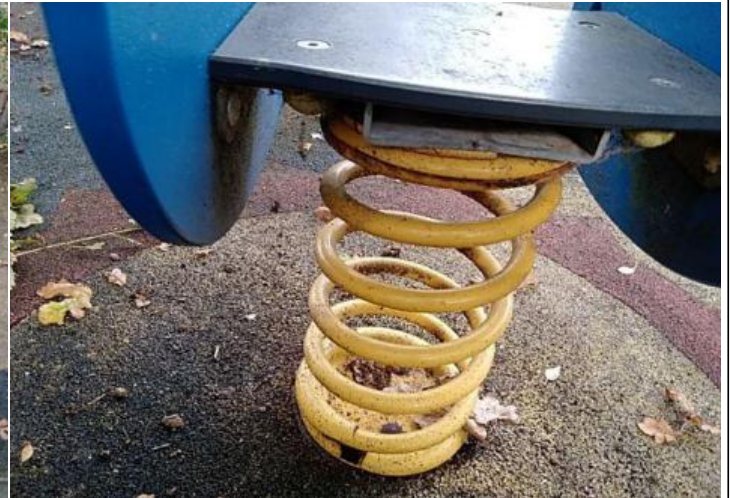
Finding: The paintwork on the spring has been damaged or worn exposing the metal underneath which is rusting
Action: Treat any rusting components and repaint

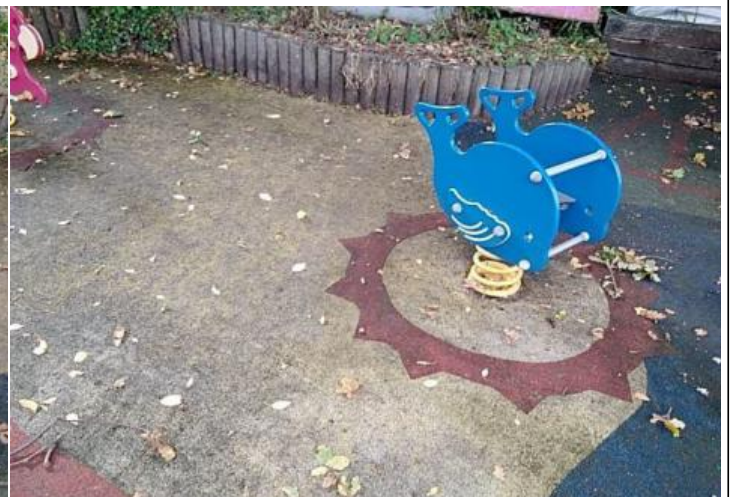
Finding: There is algae or moss growth on the surface resulting in slippery conditions
Action: Clean and treat appropriately

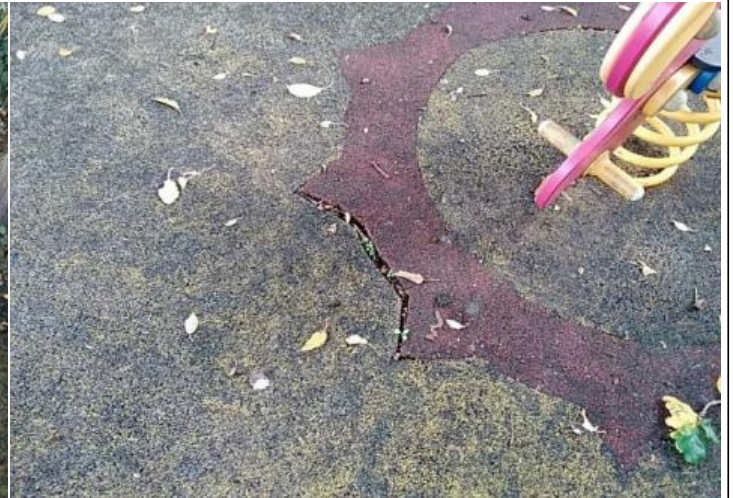
Finding: There are gaps opening between the surfacing and the edging surround or between the joints in the surfacing
Action: Monitor for any further deterioration and repair as required

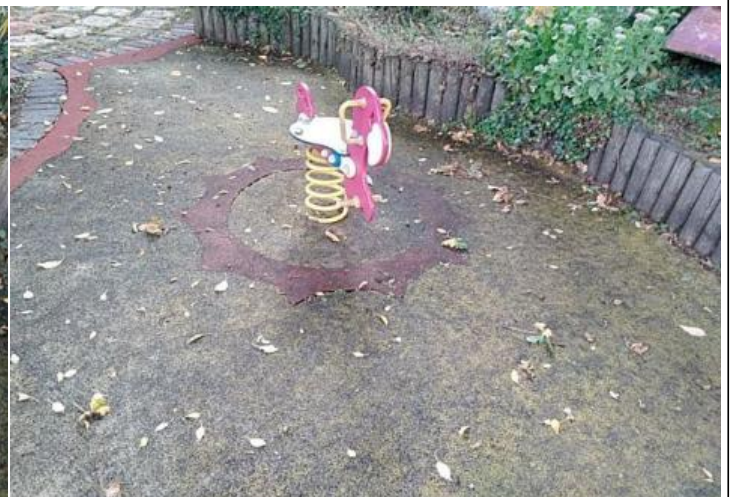
Finding: There is algae or moss growth on the surface resulting in slippery conditions
Action: Clean and treat appropriately

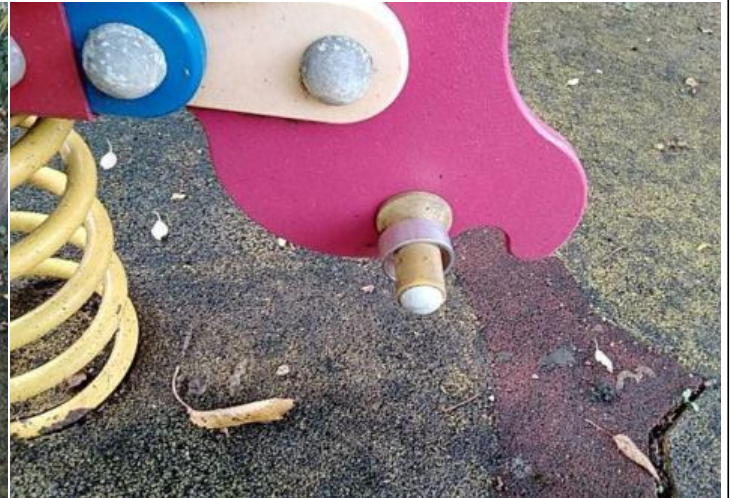
Finding: The end of handgrips and/or footrests have a cross section of less than 15cm² and fail to meet the requirements of BS EN 1176 Part 6
Action: Monitor - No remedial work recommended

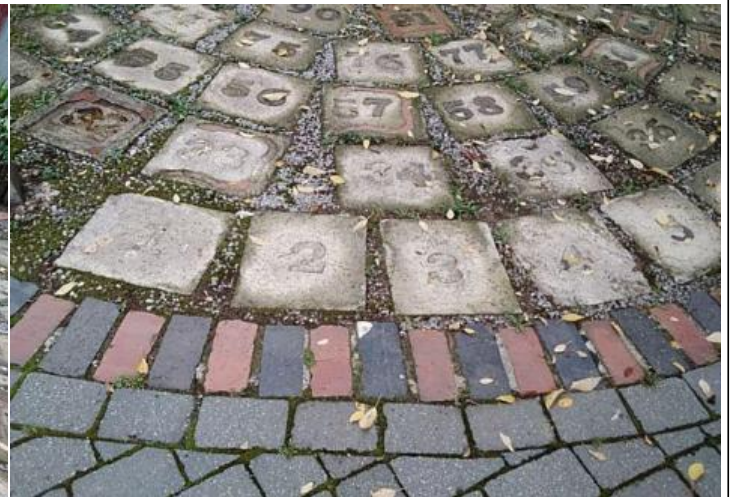
Finding: There are trip hazards at the edges of the surface
Action: Reinstate surrounding surface levels to remove the trip points

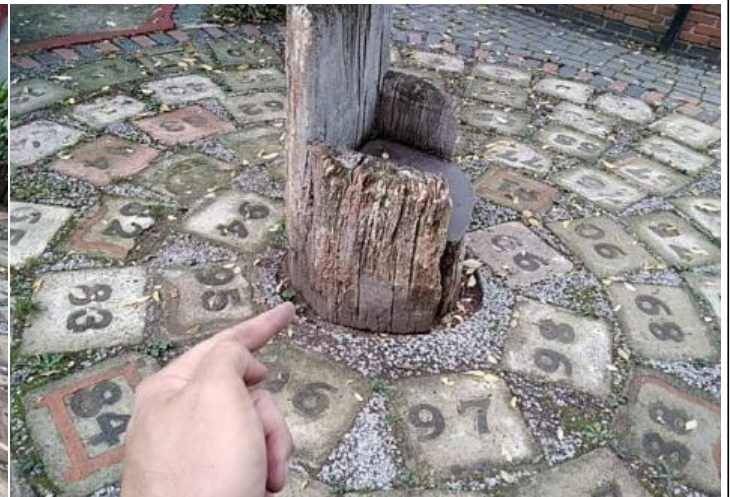
Finding: The item is loose in its foundations

Action: Reinstall item to secure

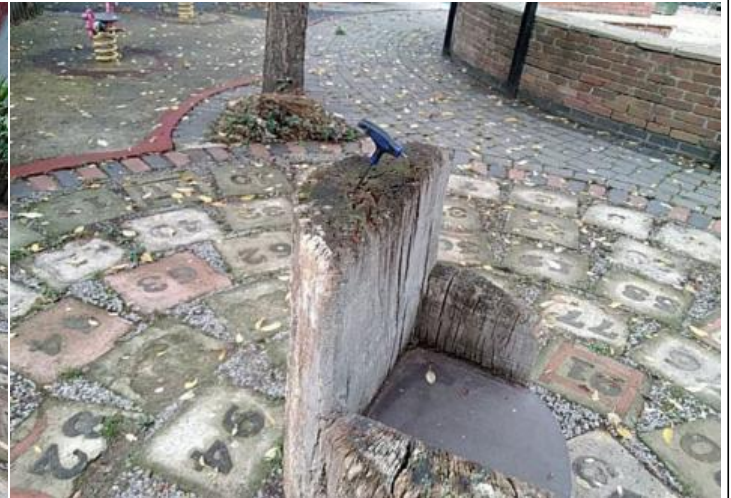
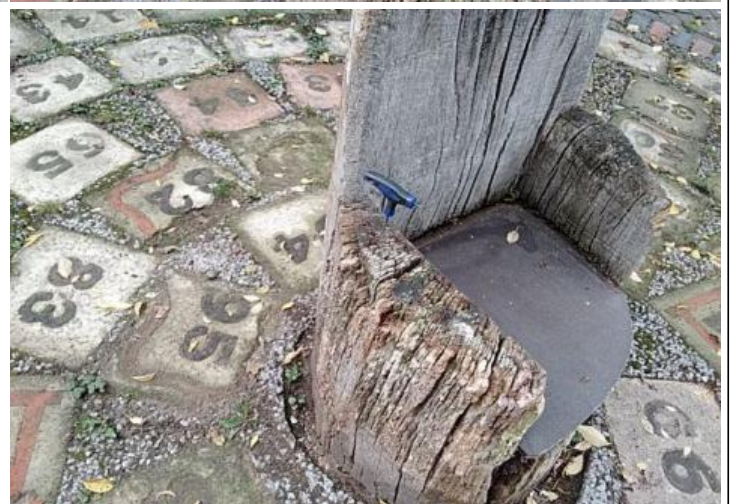
Finding: There are areas or parts of the timber on the structure that have rotted

Action: Replace all affected timbers

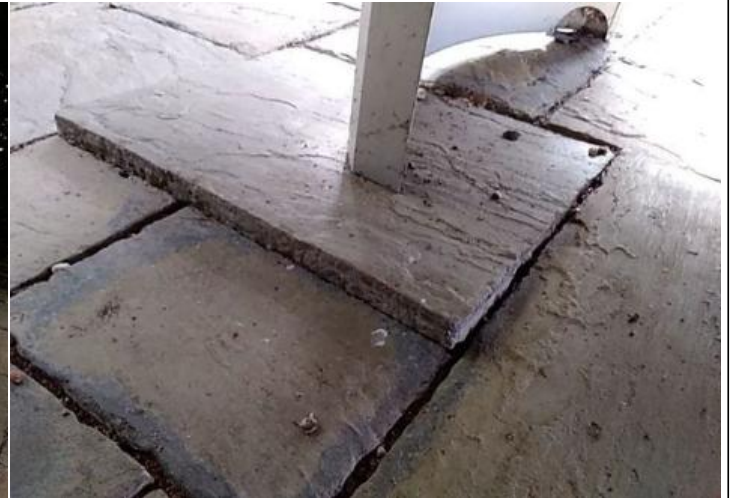
Finding: The slab is lifting at the edges and creating trip points

Action: Repair surfacing to remove trip points

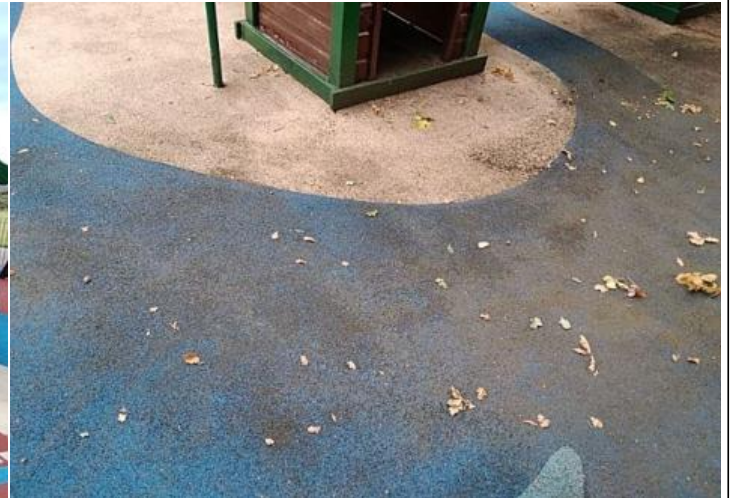
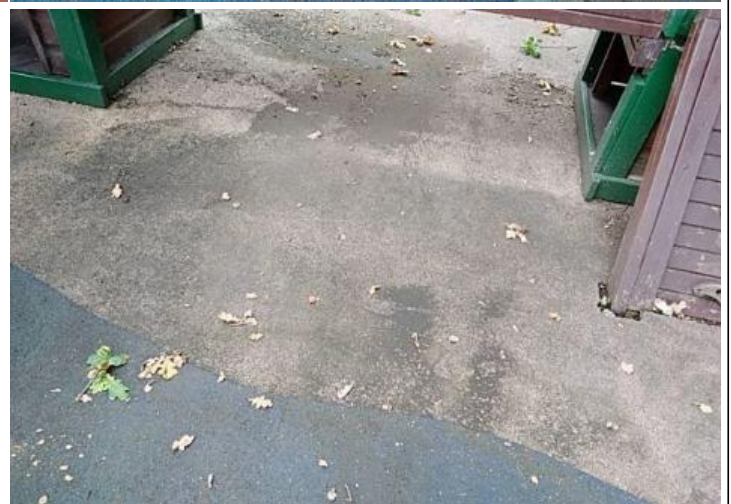
Finding: There is algae or moss growth on the surface resulting in slippery conditions

Action: Clean and treat appropriately

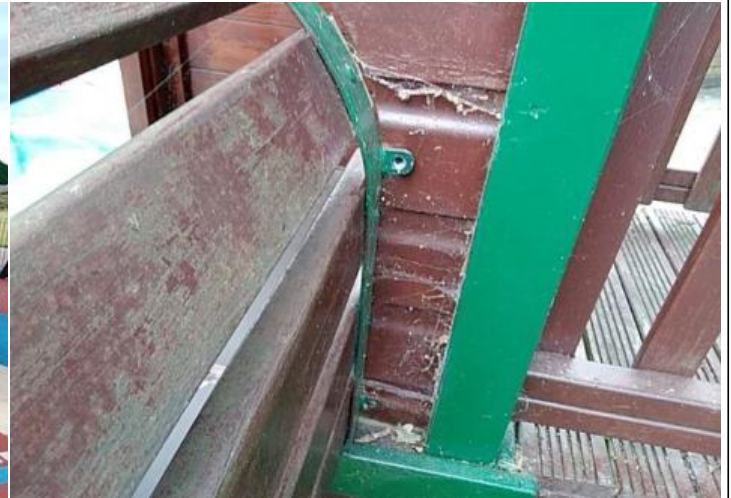
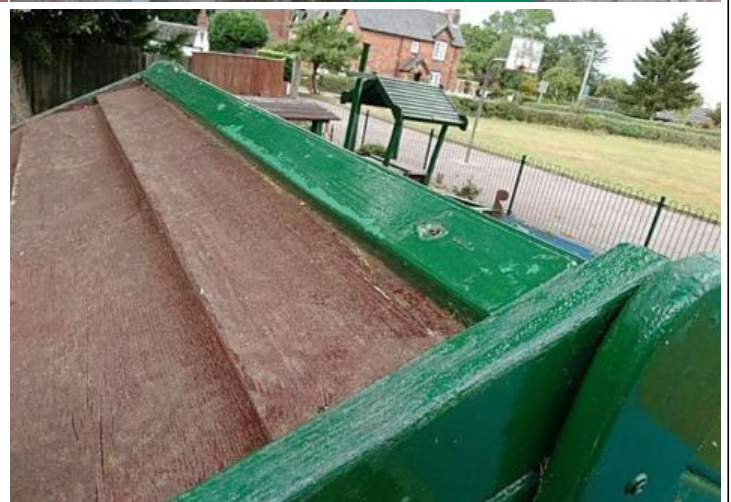
Finding: There is or are fixings missing on the item

Action: Replace all missing fixings

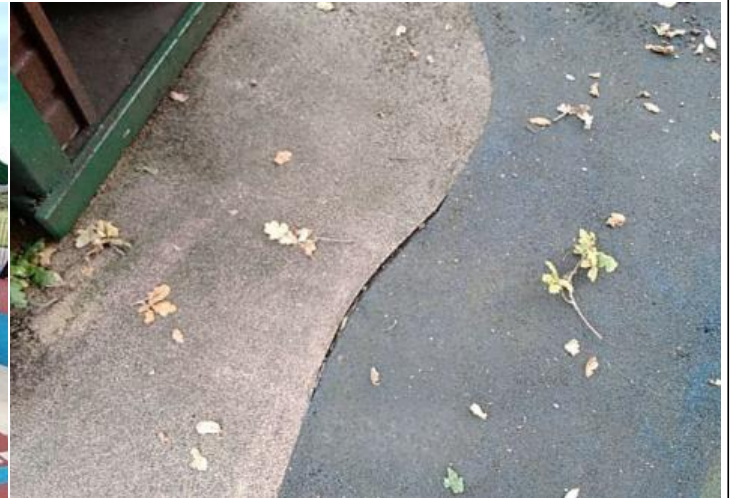
Finding: There are gaps opening between the surfacing and the edging surround or between the joints in the surfacing
Action: Monitor for any further deterioration and repair as required
