the **play inspection** company

Annual Inspection

Lichfield District Council

Elford Jubilee Memorial Playground

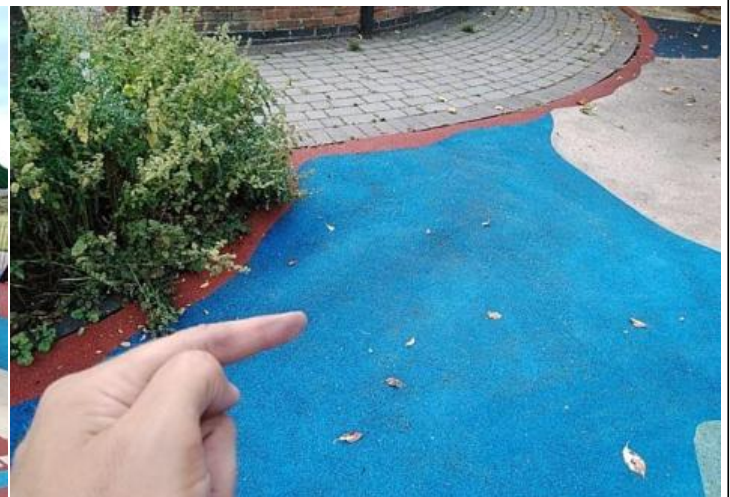
Finding: The surface has subsided in some areas
Action: Monitor for any further deterioration and repair as required

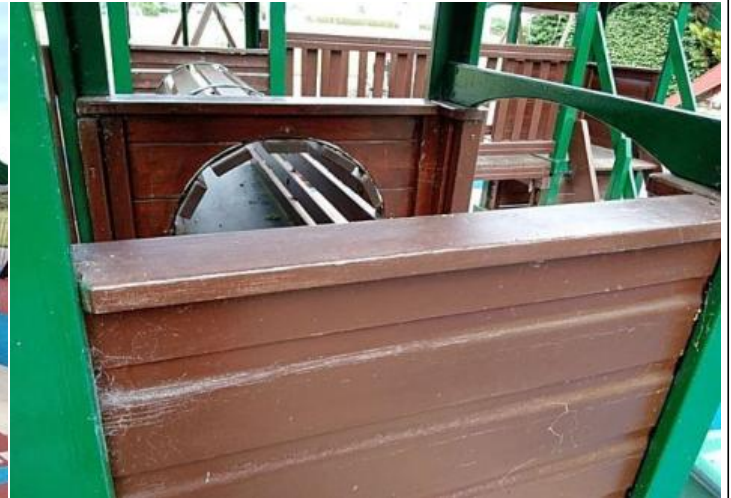
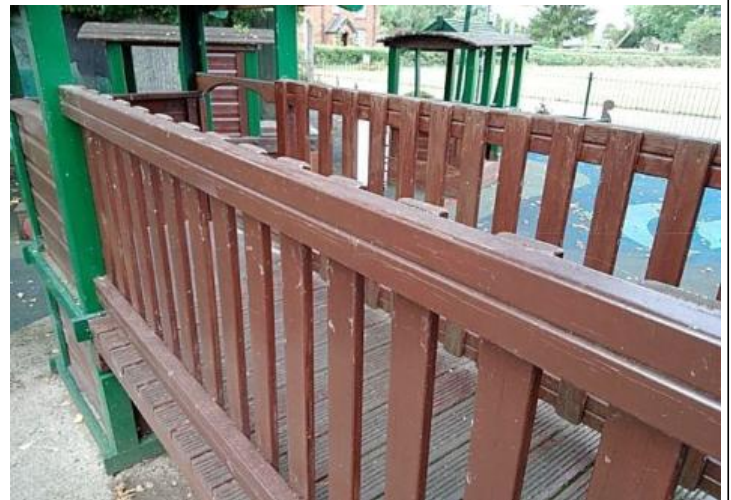
Finding: The design of the barriers encourages standing or sitting and fails the requirements of BS EN 1176

Action: Monitor - No remedial work recommended

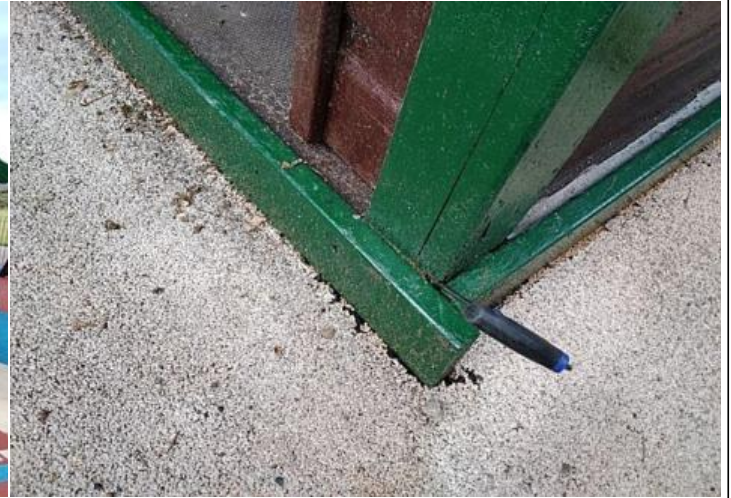
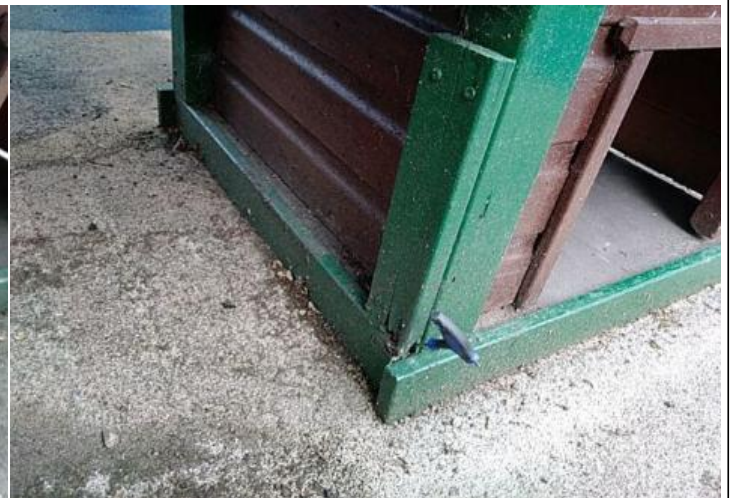
Finding: There are areas or parts of the timber on the structure that have rotted

Action: Replace all affected timbers

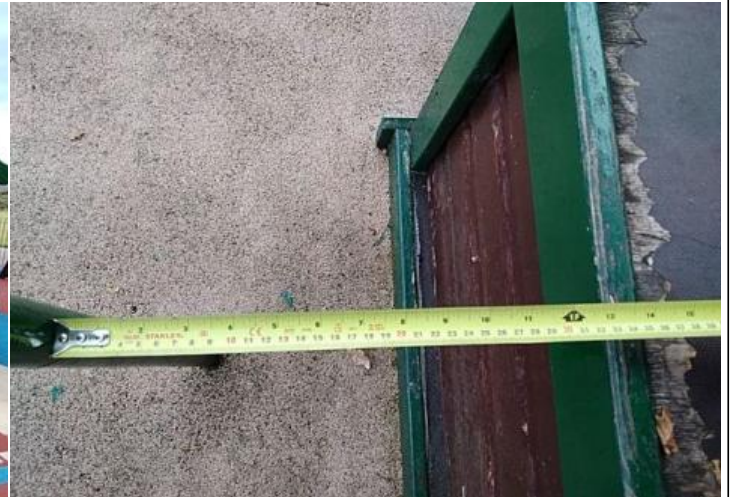
Finding: The fireman's pole is less than 350mm from the platform and fails to meet the recommendations of BS EN 1176 Part 1

Action: Monitor - no remedial action recommended

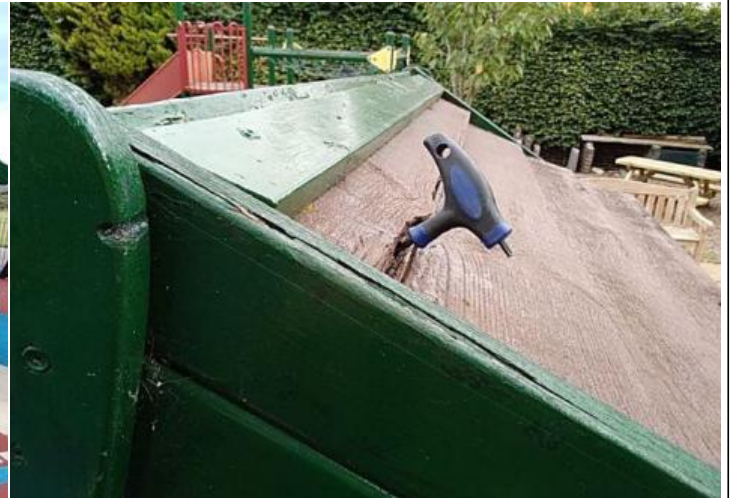
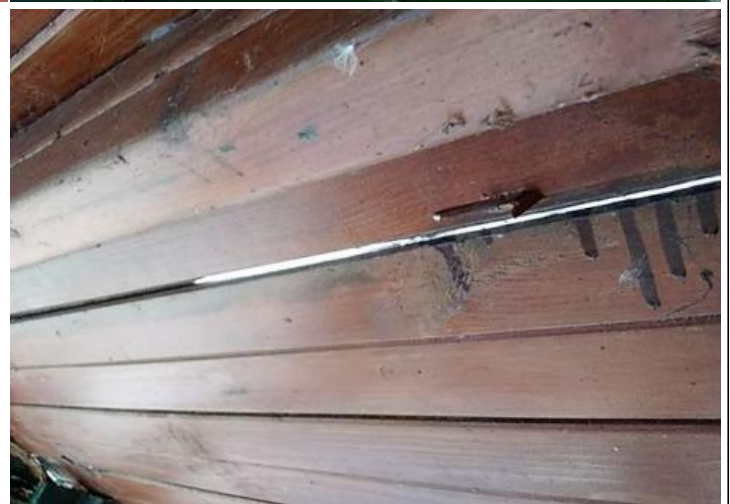
Finding: There are areas or parts of the timber roof on the structure that have rotted

Action: Replace all affected timbers

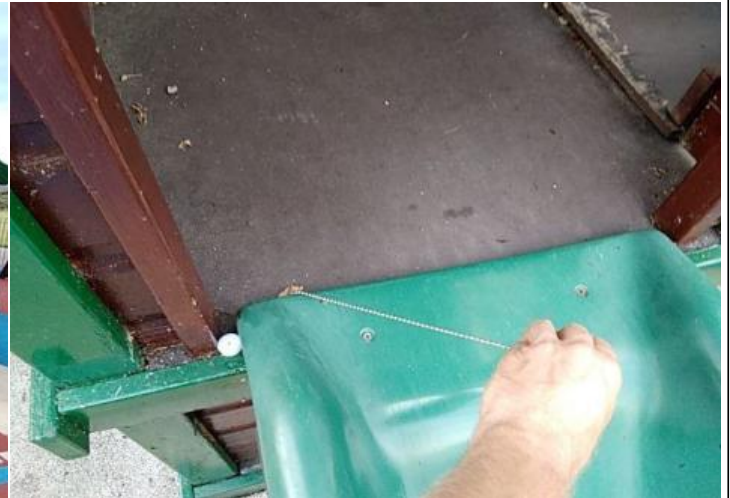
Finding: There is / are toggle entrapment/s present in contravention of the recommendations set out in BS EN 1176 Part 3

Action: Monitor - no remedial work recommended

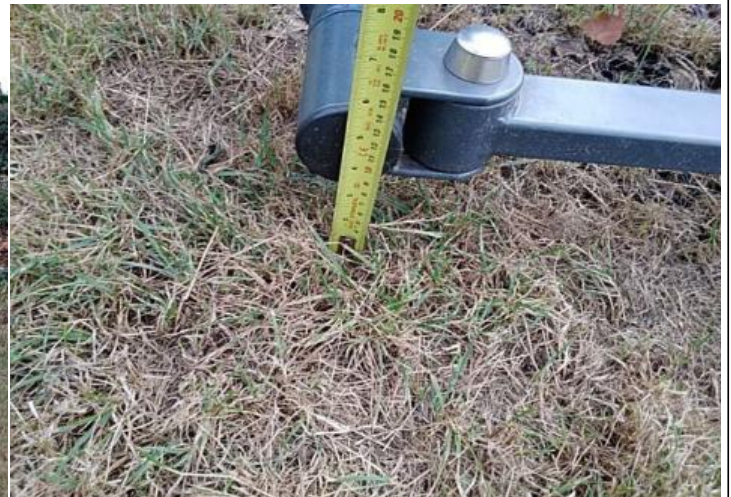
Finding: The distance between the underside of the item and the ground is less than the 110mm required by BS EN 16630

Action: Monitor - No remedial work recommended

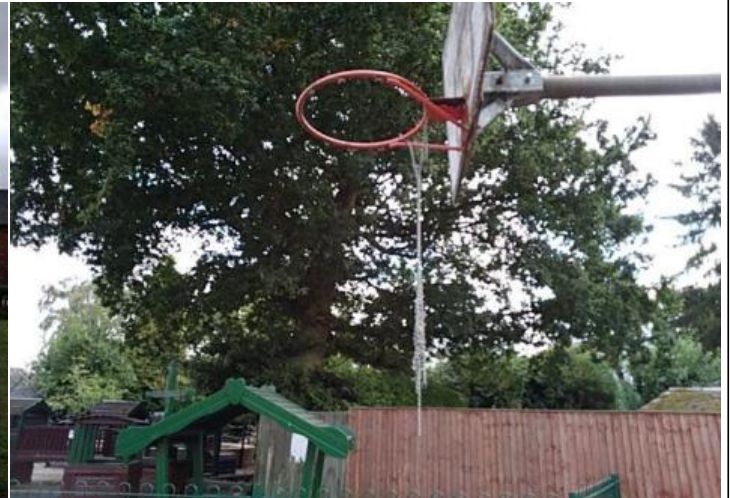
Finding: There is some damage to the chain net

Action: Replace or repair as required

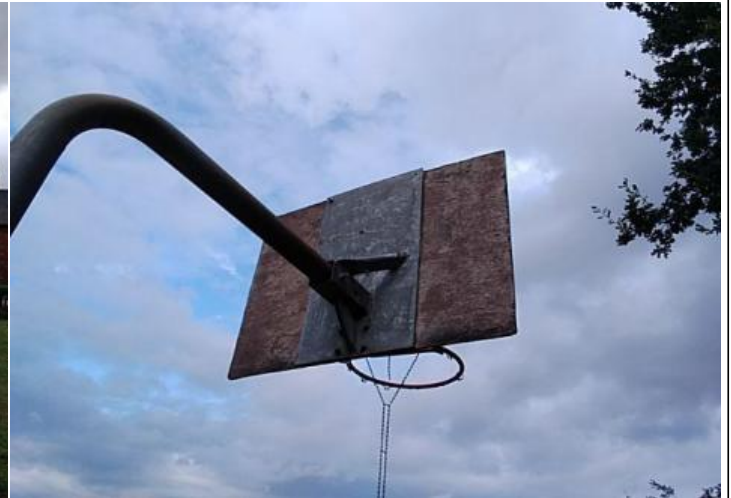
Finding: A number of fixing(s) have worked loose

Action: Secure all loose fixings
