the **play inspection** company

Annual Inspection

Lichfield District Council

Elford Jubilee Memorial Playground

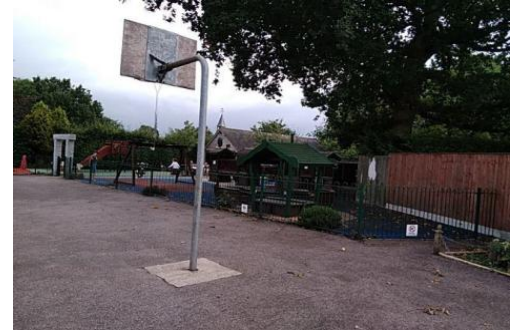
The site is accessible to the public during the COVID 19 pandemic. The government have released guidelines for safely re-opening these types of facilities which is available on the government website. - Ensure there is an appropriate risk assessment in place and review regularly

It is recommended that signage, with information including the site address, contact information for maintenance issues and emergency contact details are provided for the facility - Provide in accordance with the recommendations

There is moderate damage to the surface - Repair the damaged areas of surfacing

The surface is lifting at the edges and creating trip points - Repair perimeter of surfacing to remove trip points

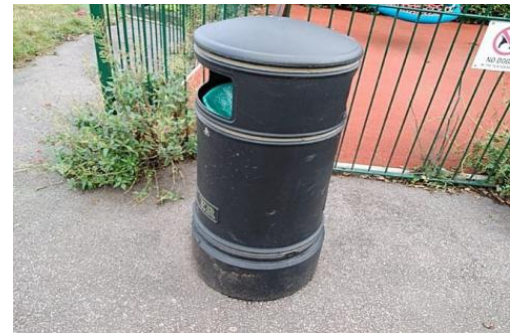
The bin is not securely fixed to the surface and there is some possibility of the item tipping or rolling over - Secure the bin to the ground

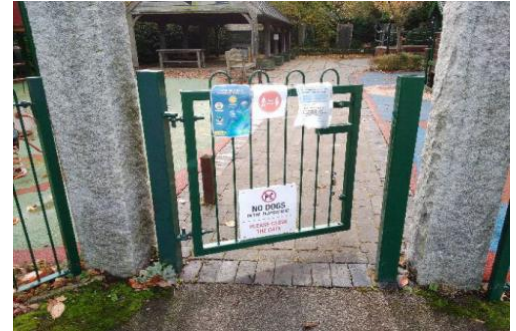
The rubber buffer is missing from the latch plate - Replace rubber buffer

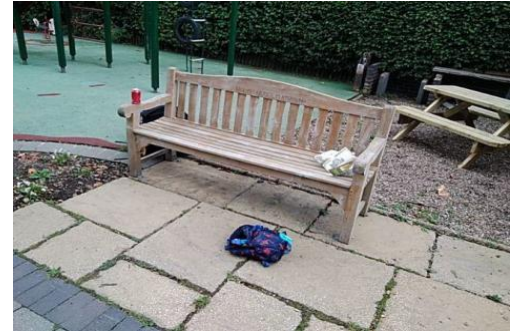
There are trip hazards at the edges of the surface - Reinststate surrounding surface levels to remove the trip points

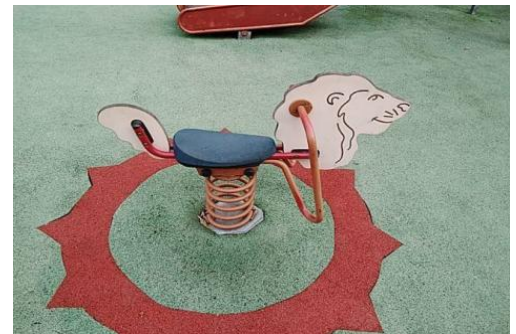
The spring clamps are loose - Tighten all loose fixings

There are gaps opening between the surfacing and the edging surround or between the joints in the surfacing - Monitor for any further deterioration and repair as required

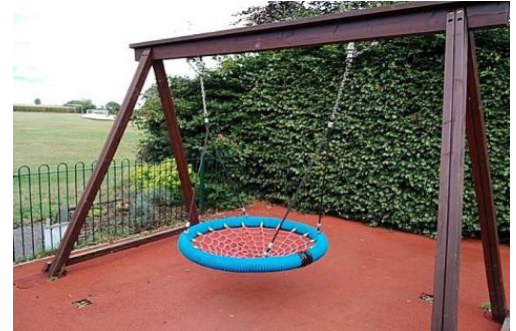
The surfacing is severely damaged exposing the concrete underneath - Repair damaged areas of surfacing

BS EN 1176 requires an additional 0.5m of unobstructed space at each end of the swing surfacing area. This is a relatively low risk finding and no remedial action is recommended at this point. - Monitor - No remedial work recommended

There is/are several inserts missing - Replace missing inserts

A number of fixing(s) have worked loose - Secure all loose fixings

The orientation of the swing joints are not in the direction of travel and this can lead to excessive wear - reinstall the joints in line with manufacturer's recommendations

The bushes are showing signs of wear - Monitor for any further deterioration and replace as required

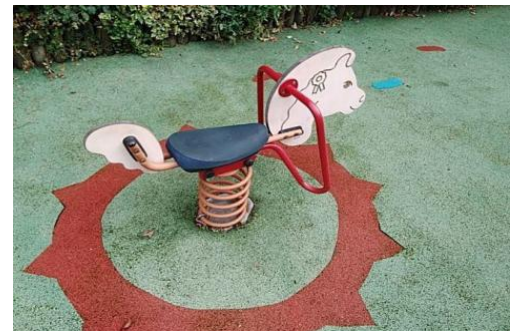
There are gaps opening between the surfacing and the edging surround or between the joints in the surfacing - Monitor for any further deterioration and repair as required

The spring clamps are loose - Tighten all loose fixings

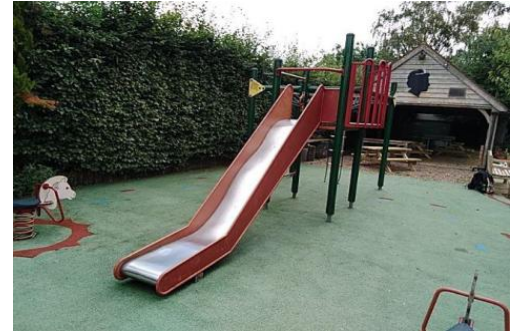
There are a number of dents in the slide surface - Monitor for any further deterioration and repair as required

There is some wear to the shackles - Monitor for any further deterioration and replace when 40% worn

The item has missing component(s) - Consider replacing missing components

There is/are bolt cap covers missing or damaged on the item - Replace missing or damaged bolt cap covers

There is/are finger entrapment/s in the redundant lugs and the item fails to meet the requirements of BS EN 1176 Part 1 4.2.7.6 Entrapment of fingers - Replace component or remove lugs

There is/are finger entrapment/s in the platform and the item fails to meet the requirements of BS EN 1176 Part 1 4.2.7.6 Entrapment of fingers - Monitor - No remedial work recommended

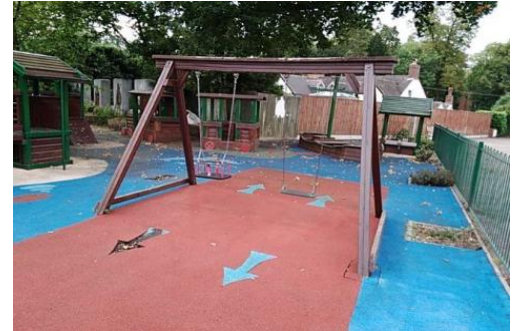
The surface is lifting at the edges and creating trip points - Repair perimeter of surfacing to remove trip points

There is/are bolt cap covers missing or damaged on the item - Replace missing or damaged bolt cap covers

There is some wear to the shackles. - Monitor for any further deterioration and replace when 40% worn

There is some wear to the lugs - Monitor for any further deterioration and replace when 40% worn

There is some evidence of rot in the timber - Monitor for any further deterioration and replace as required

There are areas or parts of the timber on the structure that have rotted - Replace all affected timbers

There are gaps opening between the surfacing and the edging surround or between the joints in the surfacing - Monitor for any further deterioration and repair as required

The swing seat connectors are loose - Tighten to secure

There is some notable evidence of chain wear - Monitor for any further deterioration and replace when 40% worn

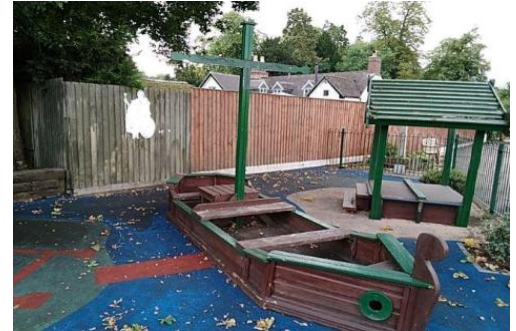
The item is slightly loose in its foundations - Monitor for any further deterioration and repair as required

The shelter forms a hard object within the impact area of the equipment in contravention of the requirements of BS EN 1176 Part 1 - Monitor - No remedial work recommended

This item of equipment relies on a single post, or a line of posts, for stability and extra care needs to be taken with equipment of this nature to avoid the potential for catastrophic failure - Ensure that regular detailed inspections are undertaken to assess for rot, corrosion and general stability

There is some evidence of rot in the timber - Monitor for any further deterioration and replace as required

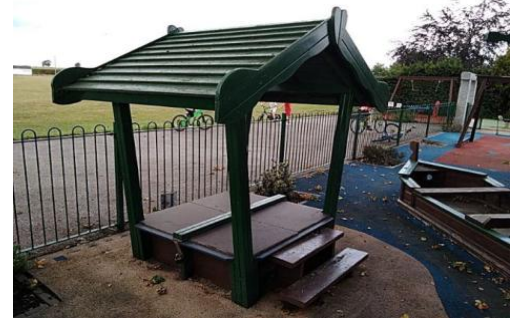
This item of equipment was not assessed during this inspection as the item was locked - Arrange inspection of the item when it is available

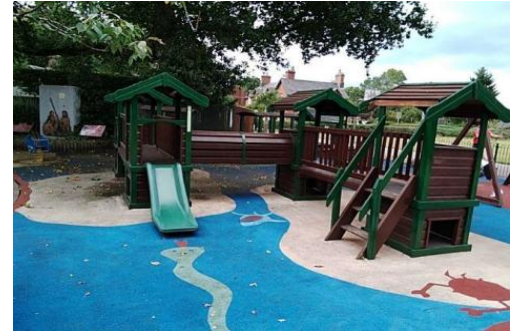
There is algae or moss growth on the surface resulting in slippery conditions - Clean and treat appropriately

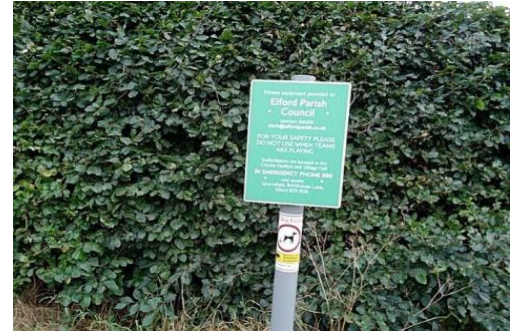
Signage should be provided for the outdoor fitness equipment in accordance with the requirements of BS EN 16630, key requirements of the sign include, but are not limited to, intended users, medical safety and emergency contact details - Provide appropriate signage

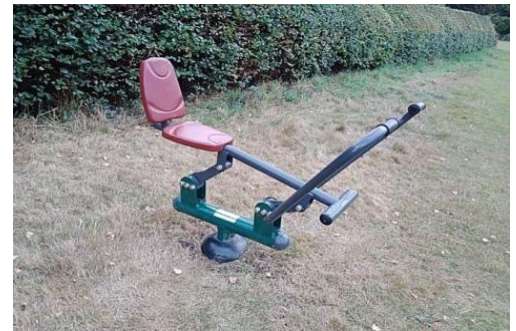
There is no clear instruction label provided; an instruction label should be provided with each item of equipment in accordance with the requirements of BS EN 16630 - Provide appropriate instruction label/s

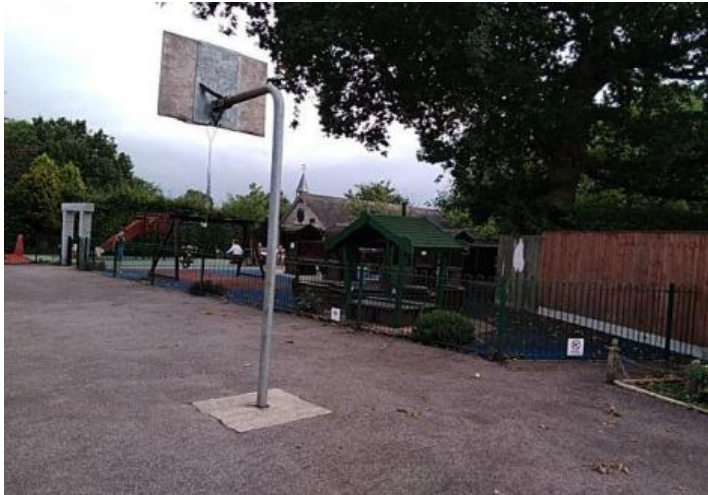
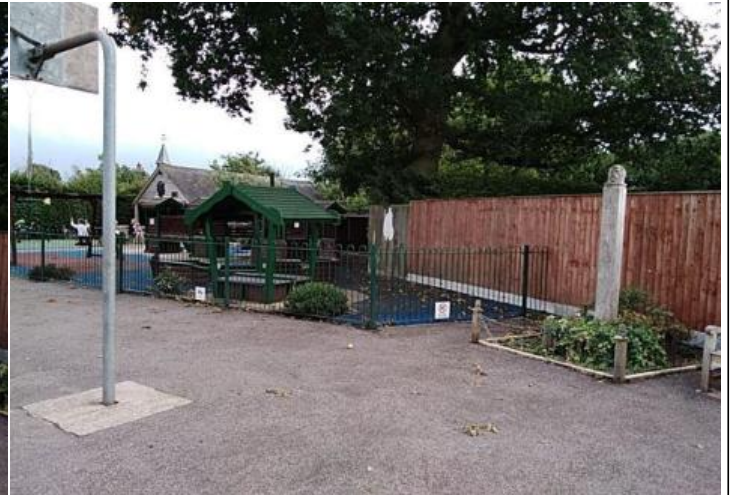
Finding: The site is accessible to the public during the COVID 19 pandemic. The government have released guidelines for safely re-opening these types of facilities which is available on the government website.

Action: Ensure there is an appropriate risk assessment in place and review regularly

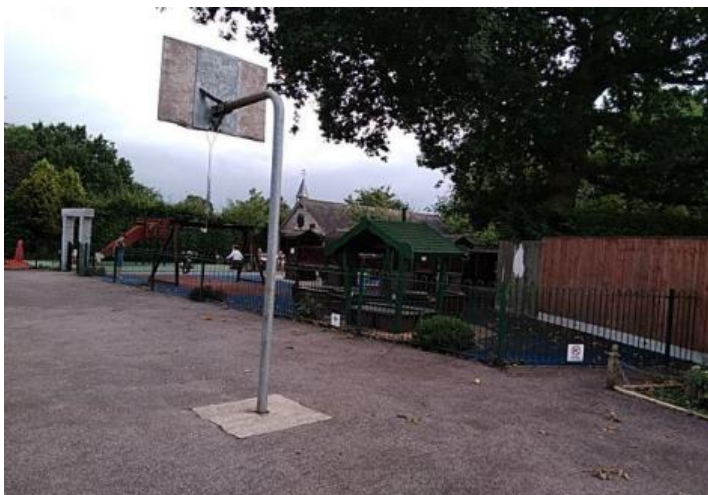
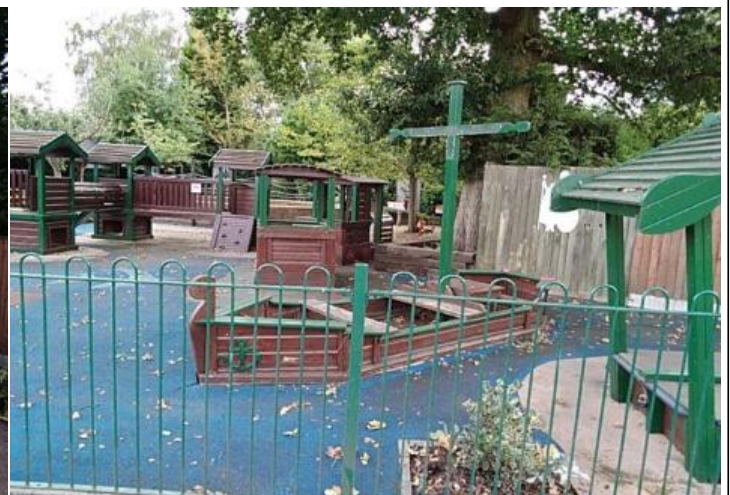
Finding: It is recommended that signage, with information including the site address, contact information for maintenance issues and emergency contact details are provided for the facility

Action: Provide in accordance with the recommendations

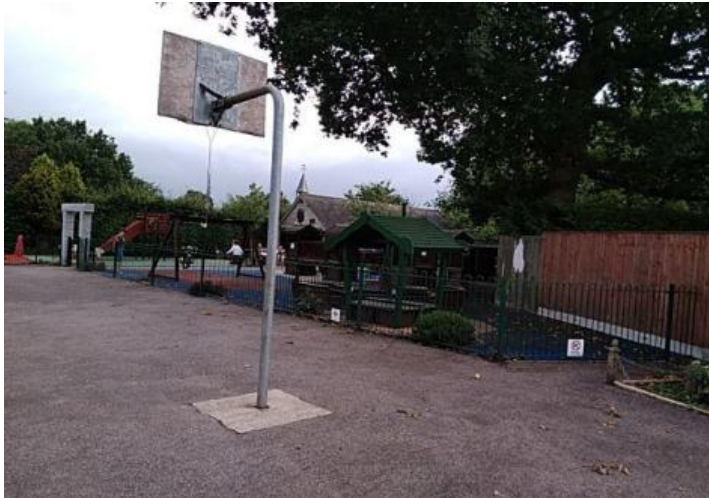
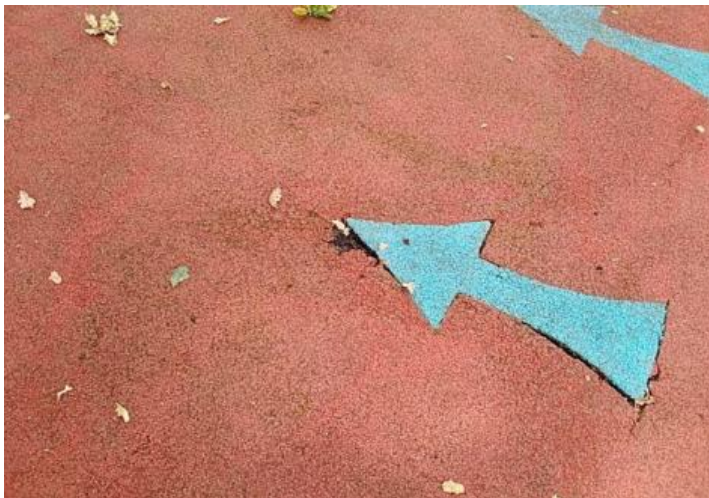
Finding: There is moderate damage to the surface

Action: Repair the damaged areas of surfacing

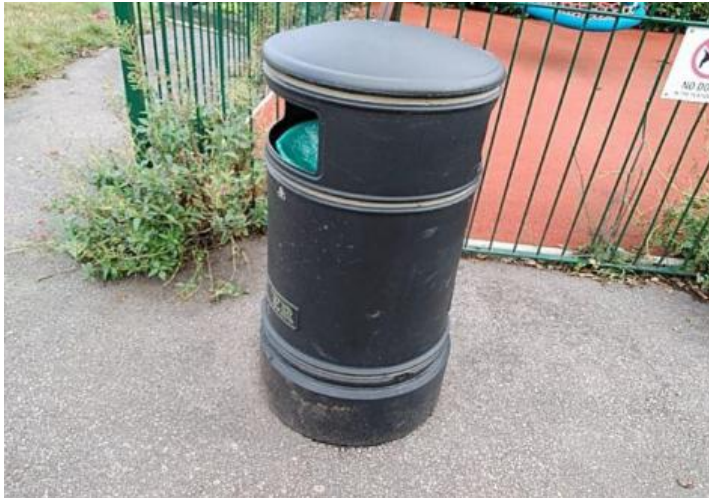
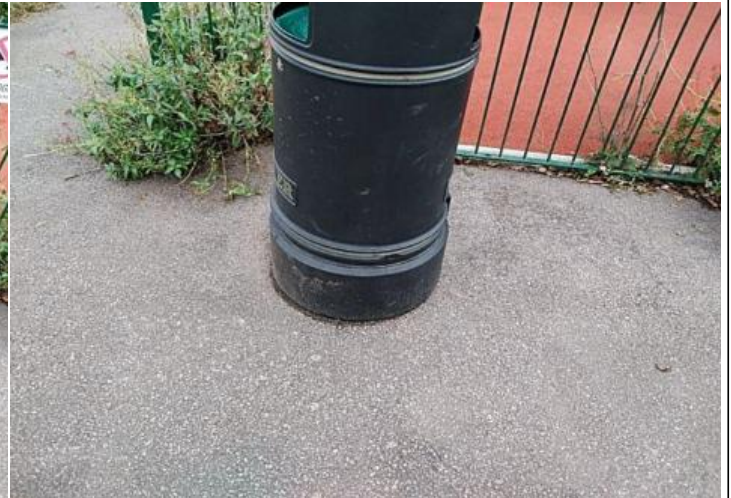
Finding: The bin is not securely fixed to the surface and there is some possibility of the item tipping or rolling over

Action: Secure the bin to the ground

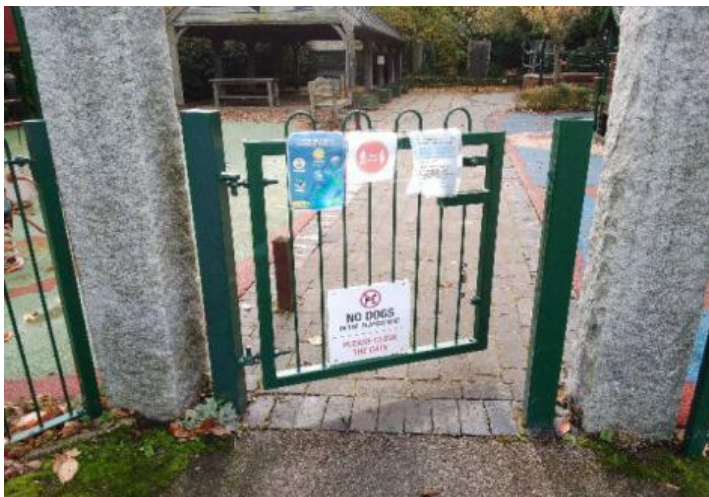
Finding: The rubber buffer is missing from the latch plate

Action: Replace rubber buffer

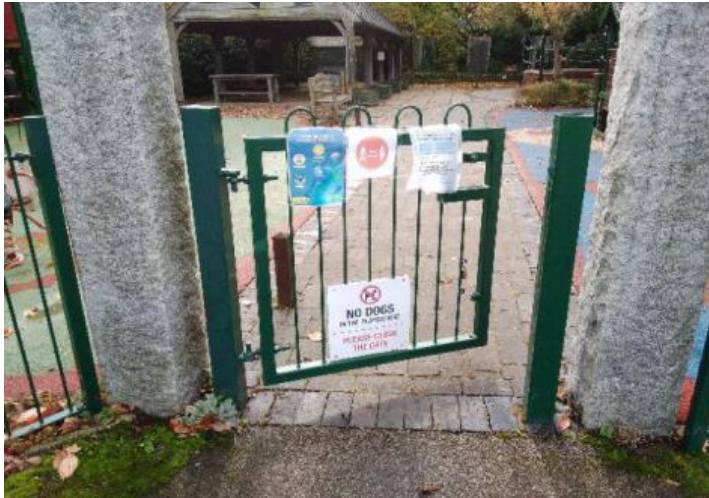
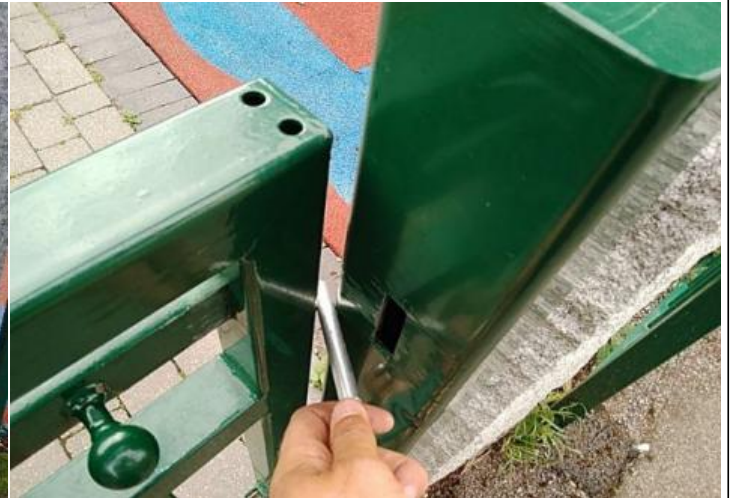
Finding: There are openings that are less than 12mm that could trap or crush fingers

Action: Where possible a 12mm gap should be maintained on both sides or between the gate leaves

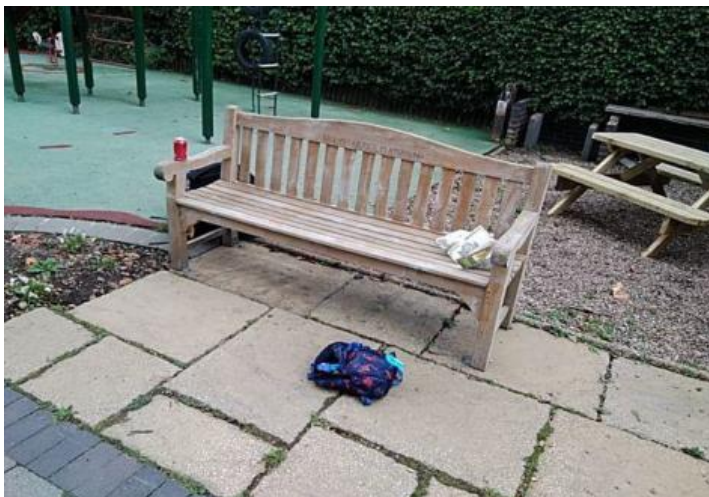
Finding: There are trip hazards at the edges of the surface

Action: Reinstate surrounding surface levels to remove the trip points

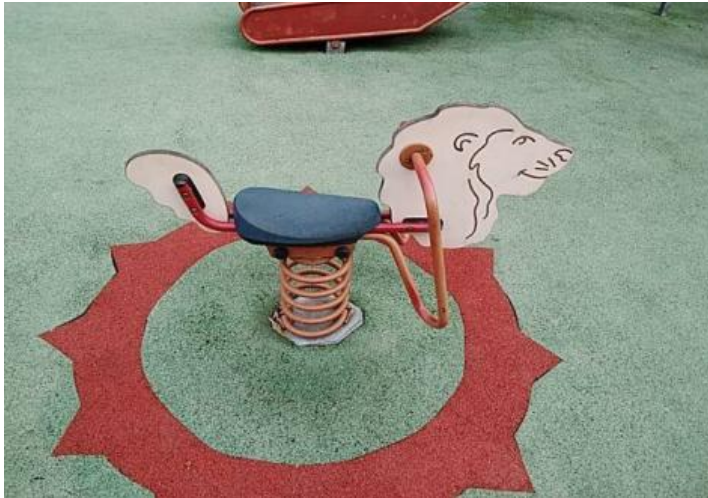
Finding: The spring clamps are loose

Action: Tighten all loose fixings

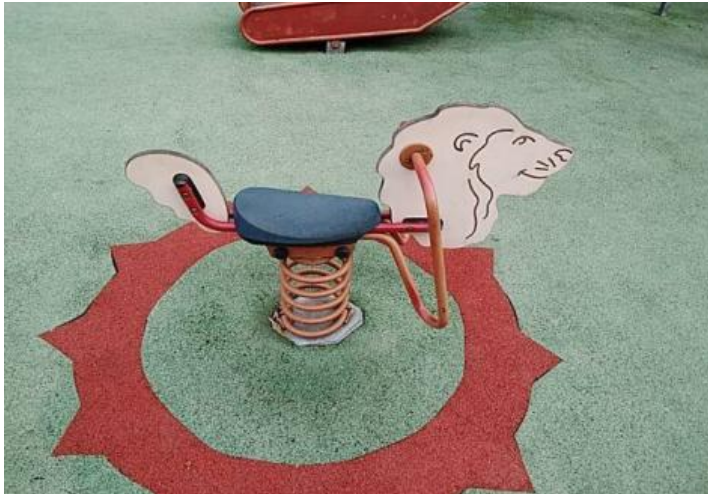
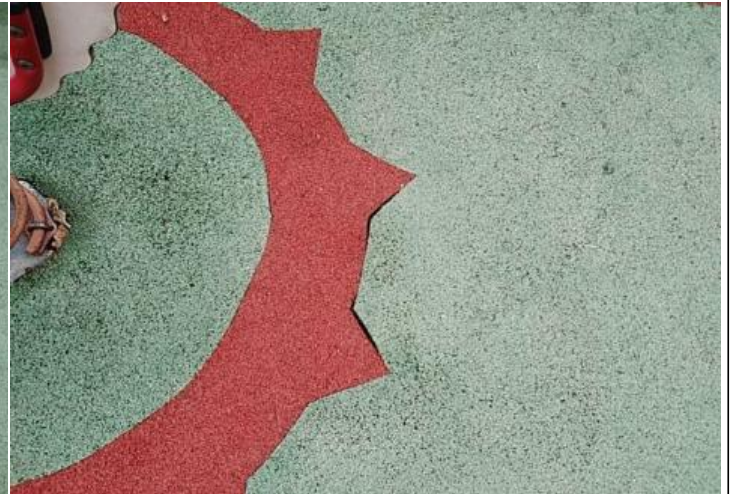
Finding: There are gaps opening between the surfacing and the edging surround or between the joints in the surfacing

Action: Monitor for any further deterioration and repair as required

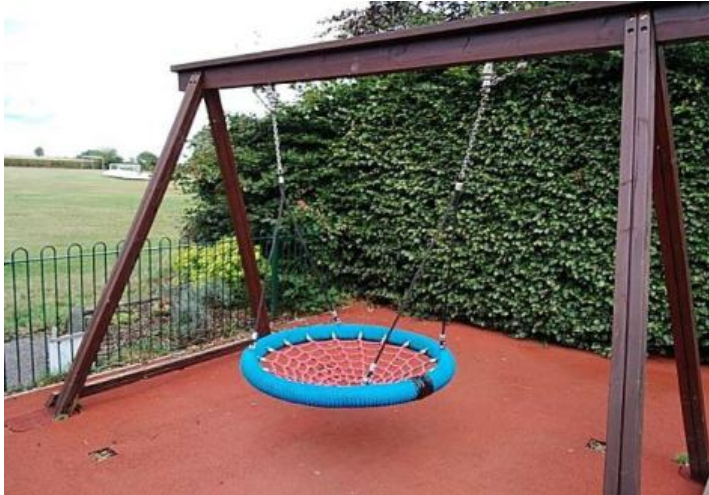
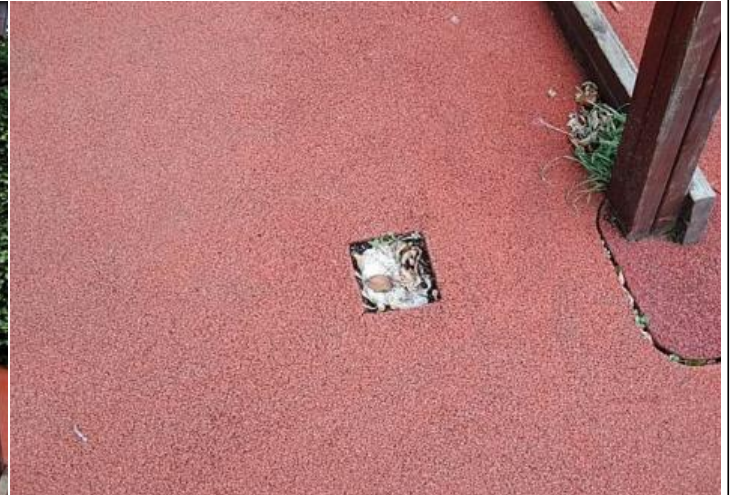
Finding: The surfacing is severely damaged exposing the concrete underneath

Action: Repair damaged areas of surfacing

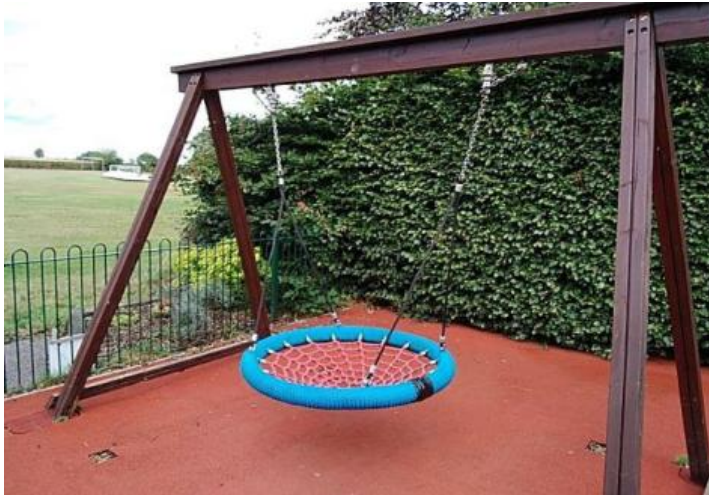
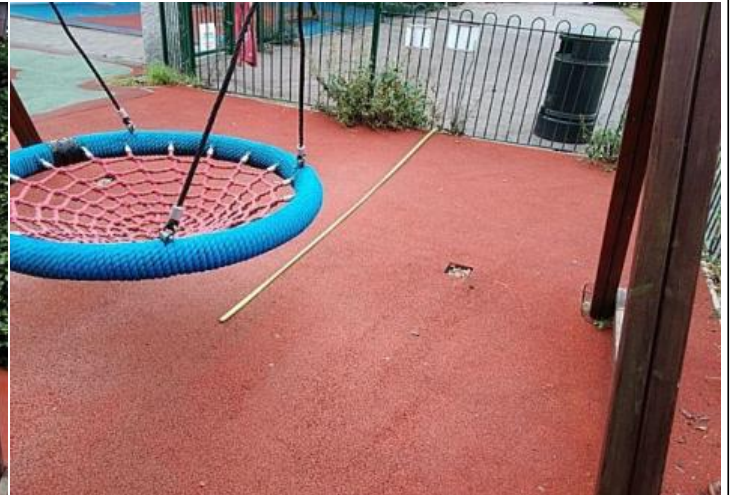
Finding: BS EN 1176 requires an additional 0.5m of unobstructed space at each end of the swing surfacing area. This is a relatively low risk finding and no remedial action is recommended at this point.

Action: Monitor - No remedial work recommended

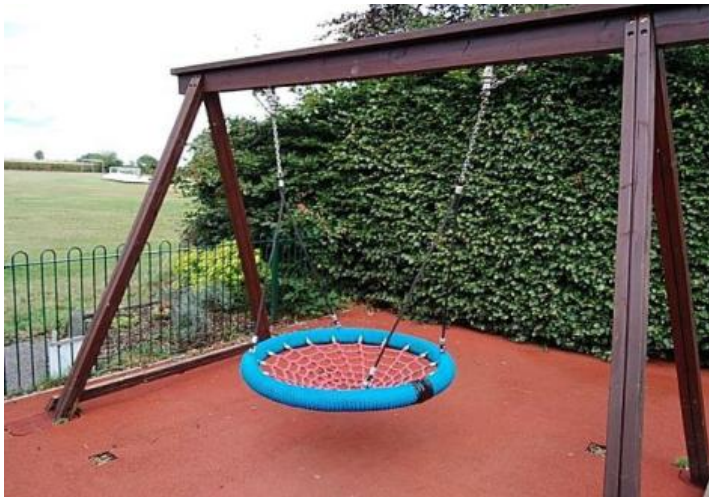
Finding: There is/are several inserts missing

Action: Replace missing inserts

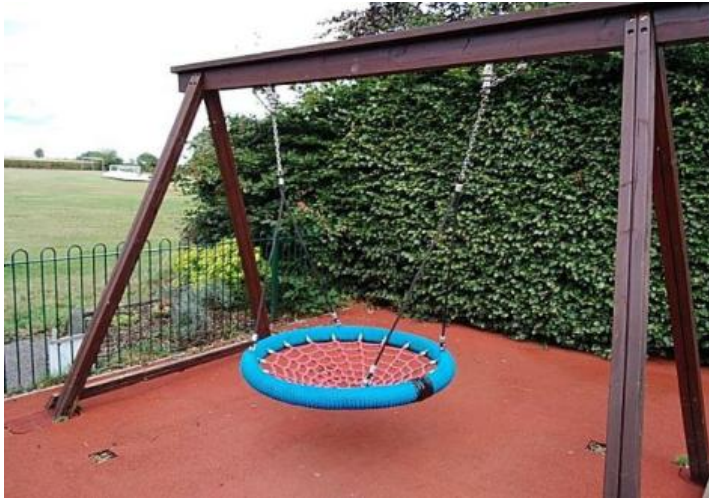
Finding: A number of fixing(s) have worked loose

Action: Secure all loose fixings

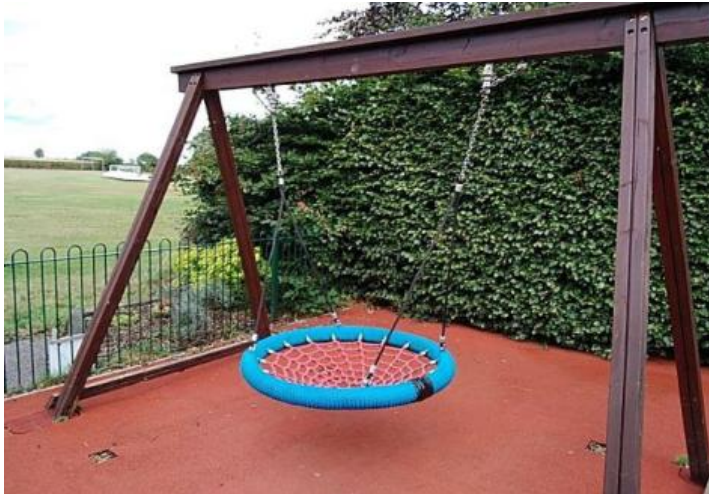
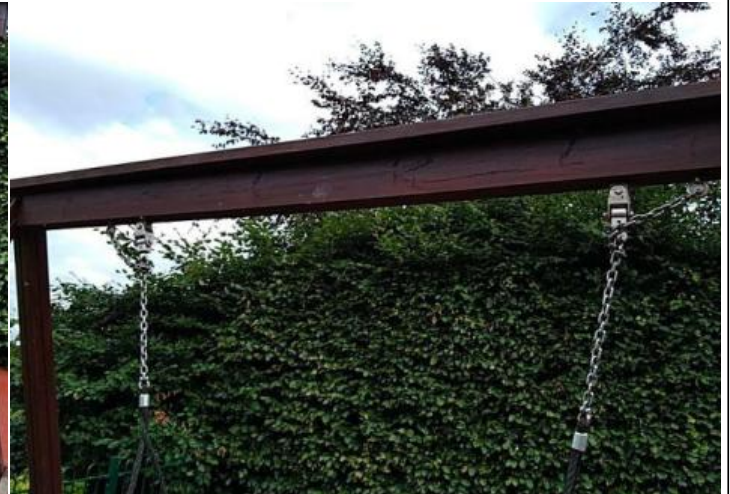
Finding: The orientation of the swing joints are not in the direction of travel and this can lead to excessive wear

Action: reinstall the joints in line with manufacturer's recommendations

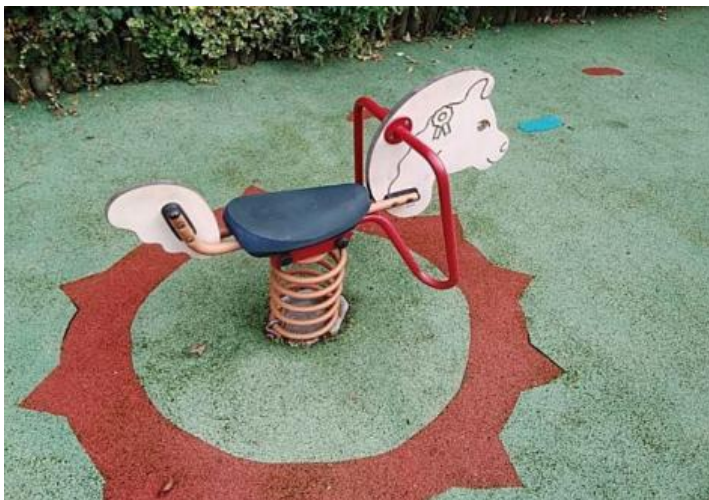
Finding: There are gaps opening between the surfacing and the edging surround or between the joints in the surfacing

Action: Monitor for any further deterioration and repair as required

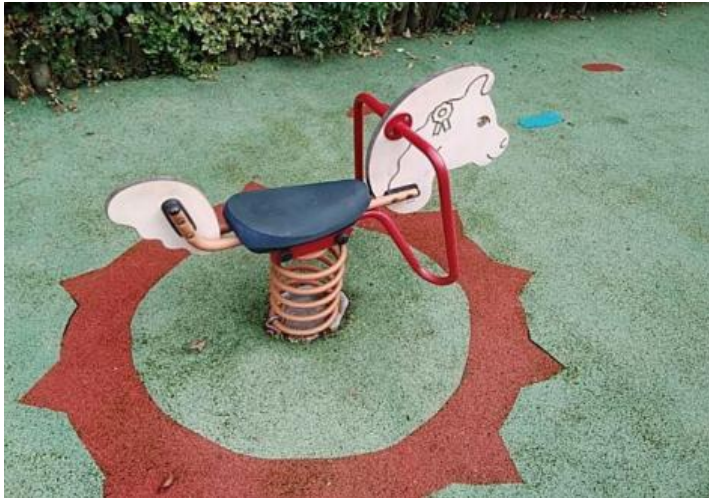
Finding: The spring clamps are loose

Action: Tighten all loose fixings

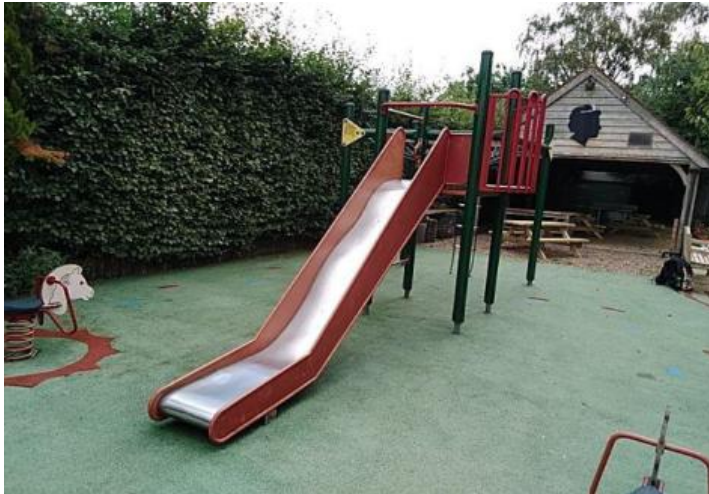
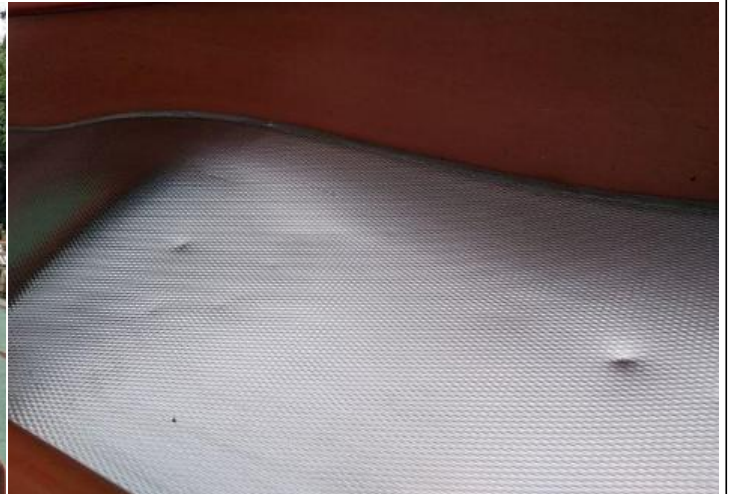
Finding: There are a number of dents in the slide surface

Action: Monitor for any further deterioration and repair as required

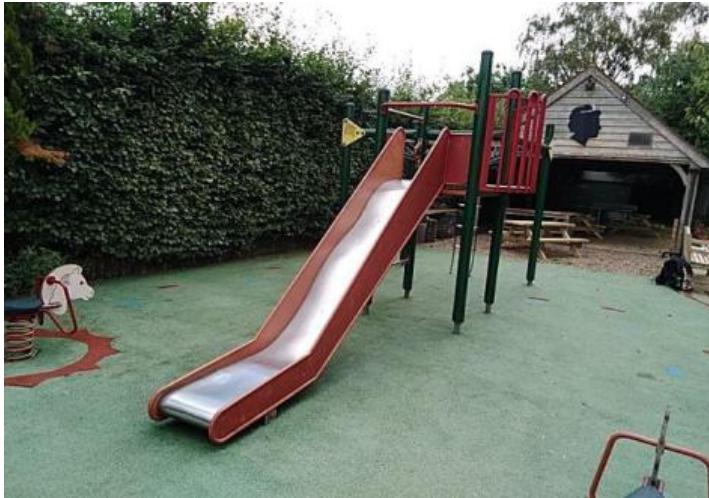
Finding: There is/are bolt cap covers missing or damaged on the item

Action: Replace missing or damaged bolt cap covers

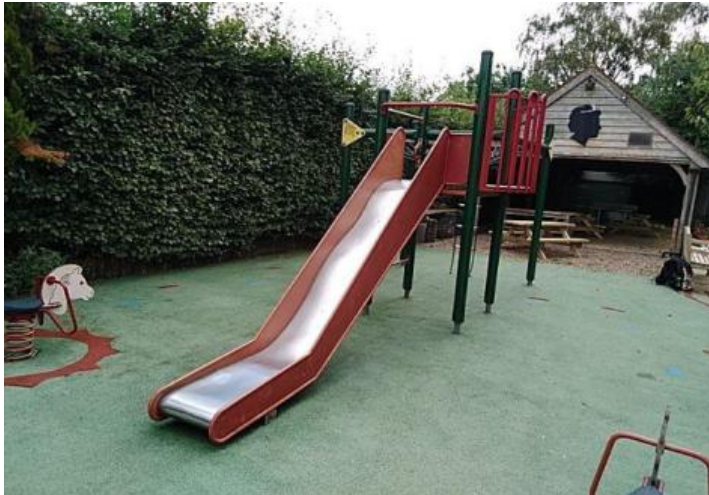
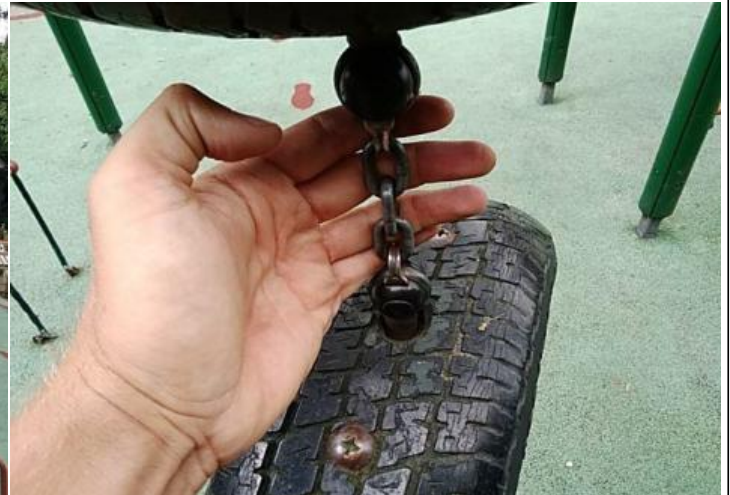
Finding: There is some wear to the shackles

Action: Monitor for any further deterioration and replace when 40% worn

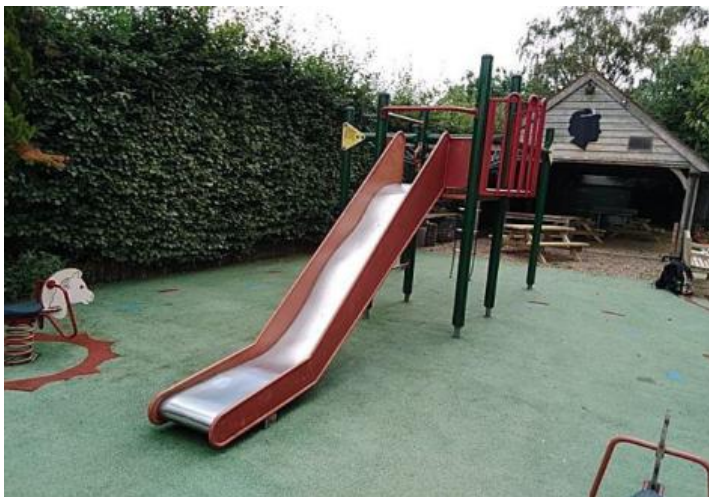
Finding: There is/are finger entrapment/s in the redundant lugs and the item fails to meet the requirements of BS EN 1176 Part 1 4.2.7.6 Entrapment of fingers

Action: Replace component or remove lugs

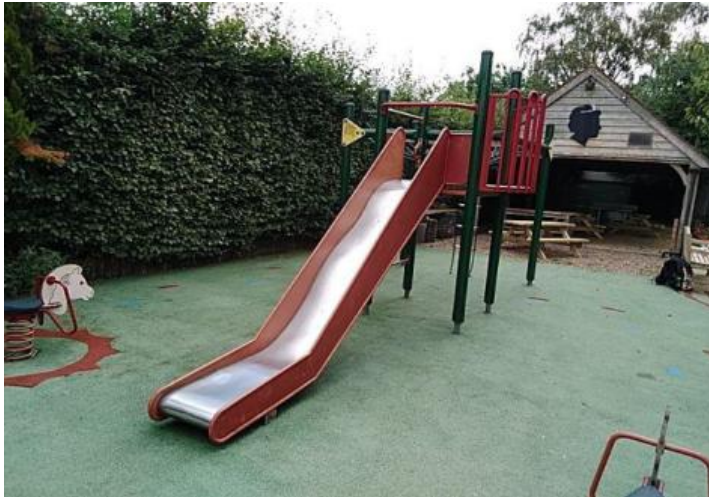
Finding: There is/are finger entrapment/s in the platform and the item fails to meet the requirements of BS EN 1176 Part 1 4.2.7.6 Entrapment of fingers

Action: Monitor - No remedial work recommended

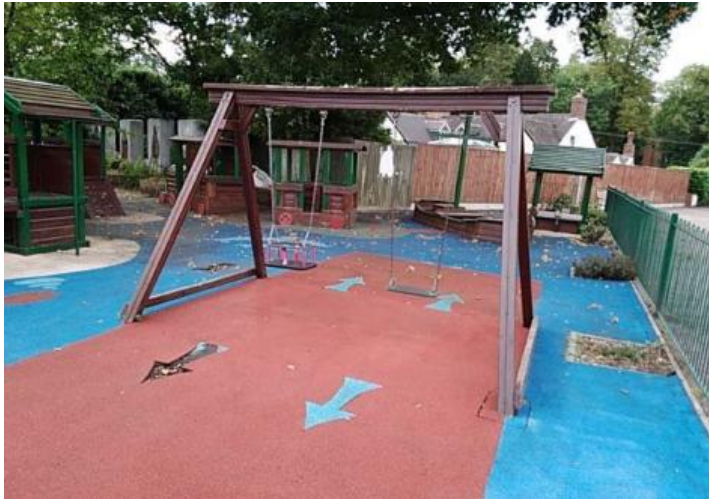
Finding: The surface is lifting at the edges and creating trip points

Action: Repair perimeter of surfacing to remove trip points

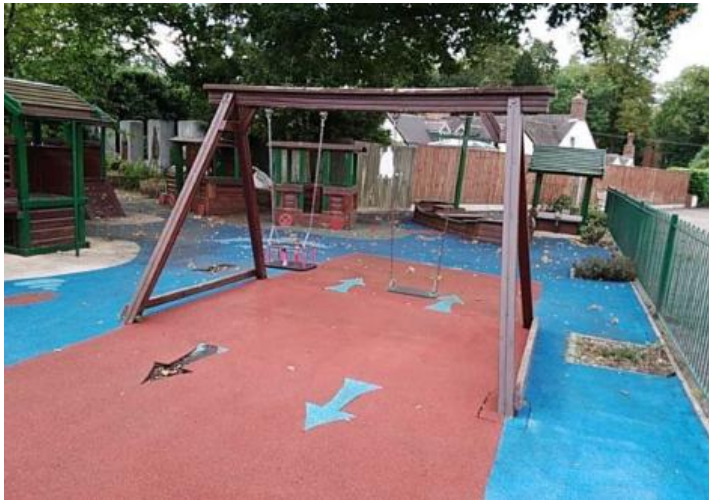
Finding: There are areas or parts of the timber on the structure that have rotted

Action: Replace all affected timbers

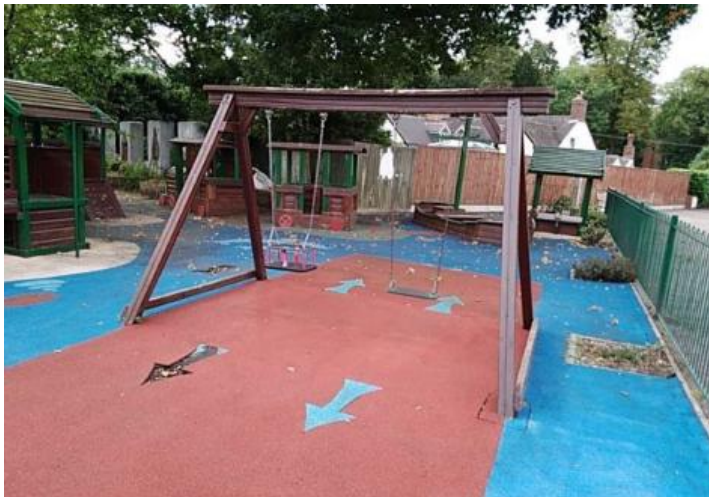
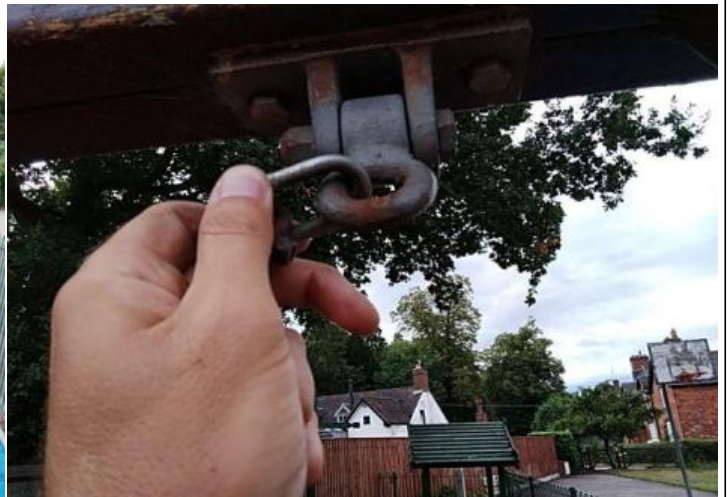
Finding: There is some wear to the shackles.
Action: Monitor for any further deterioration and replace when 40% worn

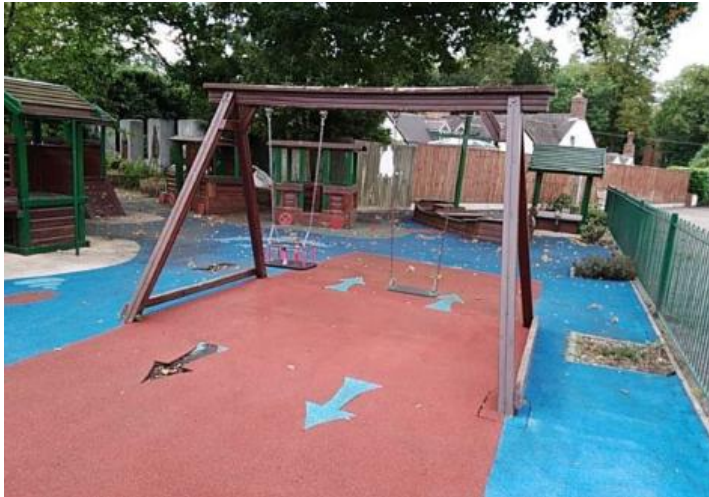
Finding: The swing seat connectors are loose

Action: Tighten to secure

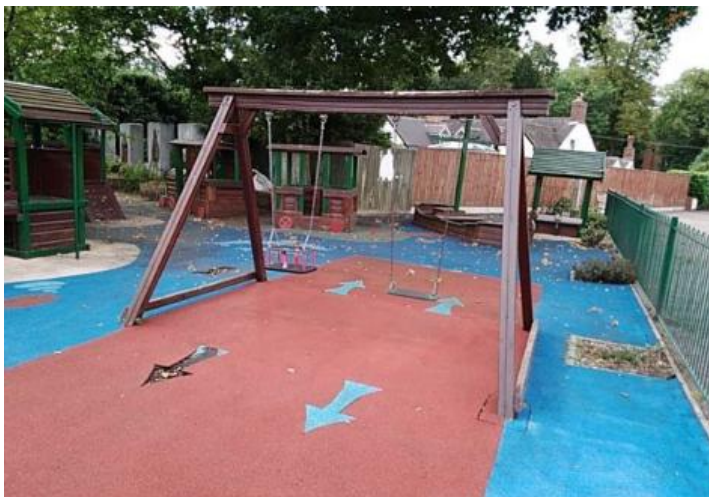
Finding: There is some wear to the lugs

Action: Monitor for any further deterioration and replace when 40% worn

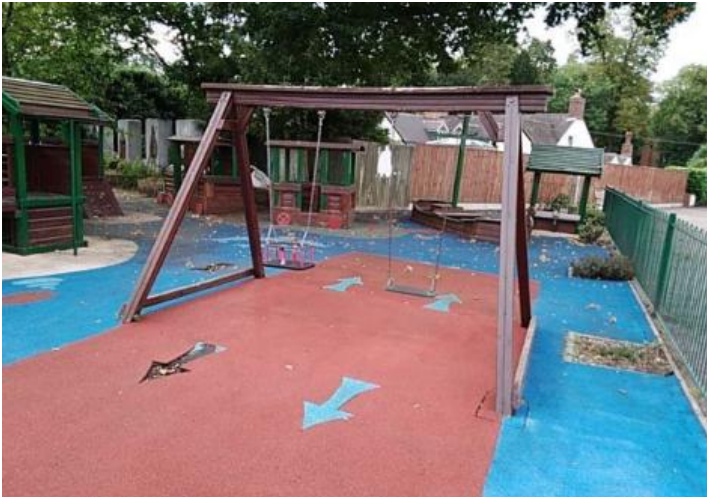
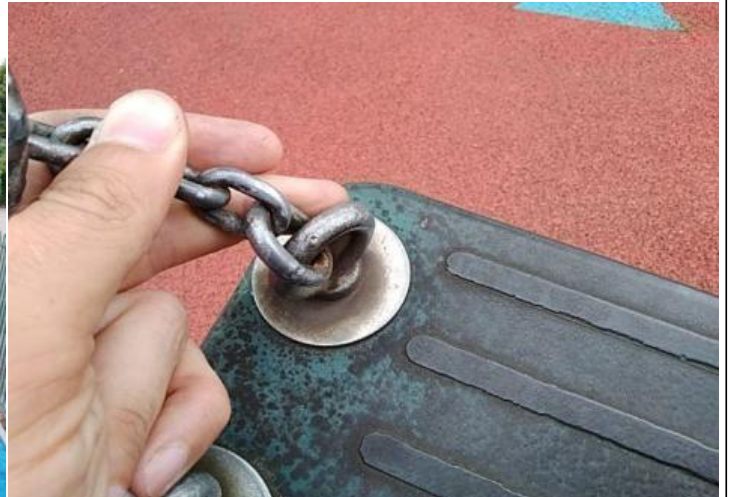
Finding: There is some notable evidence of chain wear

Action: Monitor for any further deterioration and replace when 40% worn

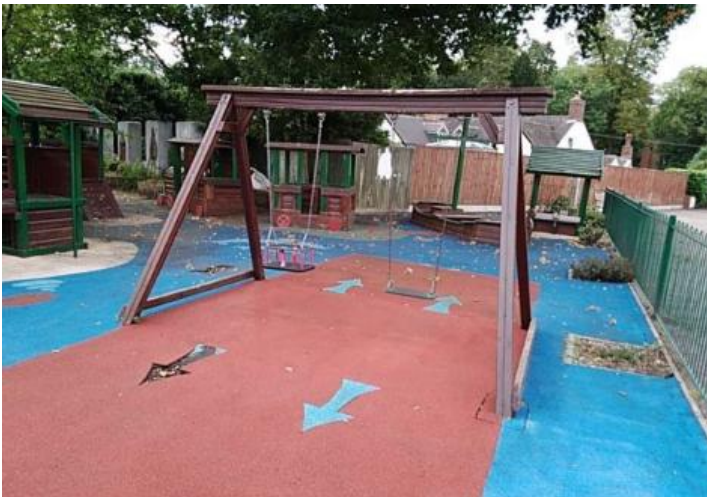
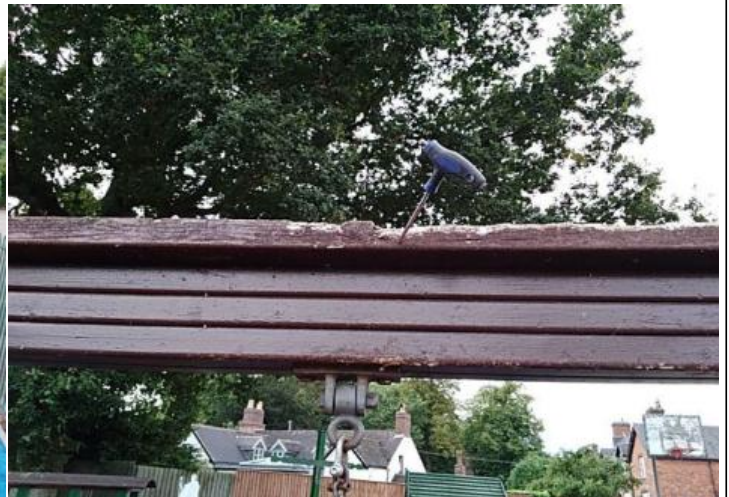
Finding: There is some evidence of rot in the timber

Action: Monitor for any further deterioration and replace as required

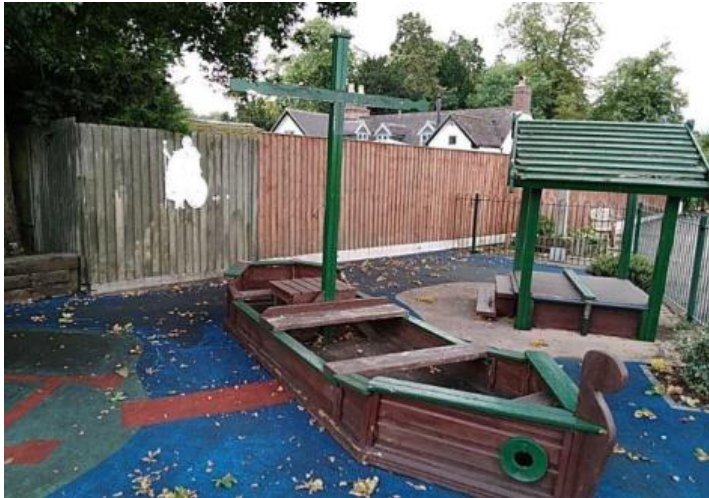
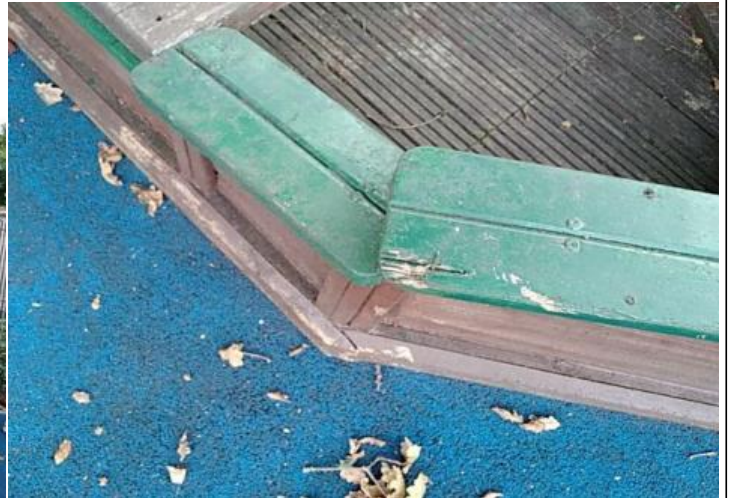
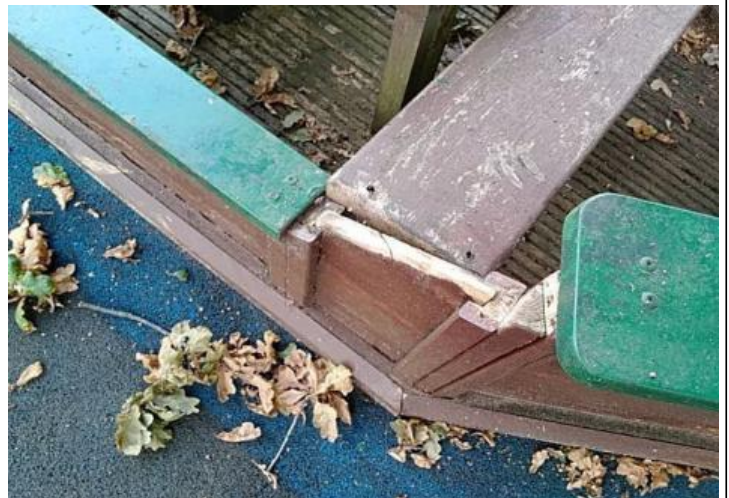
Finding: Parts of the timber are rough or splintered

Action: Remove all rough or sharp edges

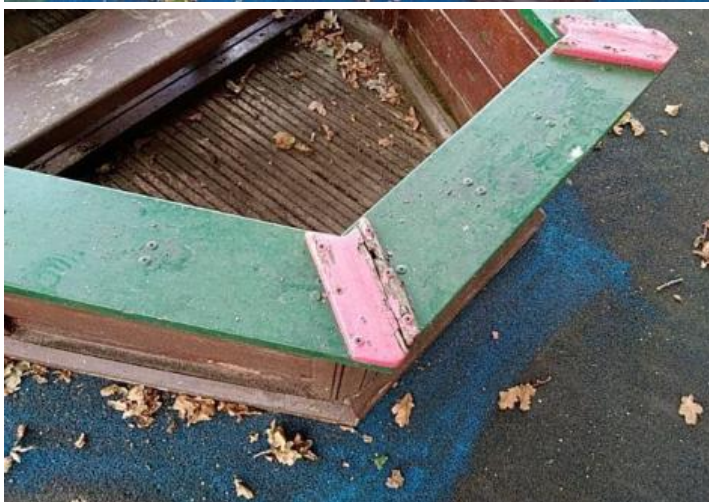
Finding: There is some evidence of rot in the timber

Action: Monitor for any further deterioration and replace as required

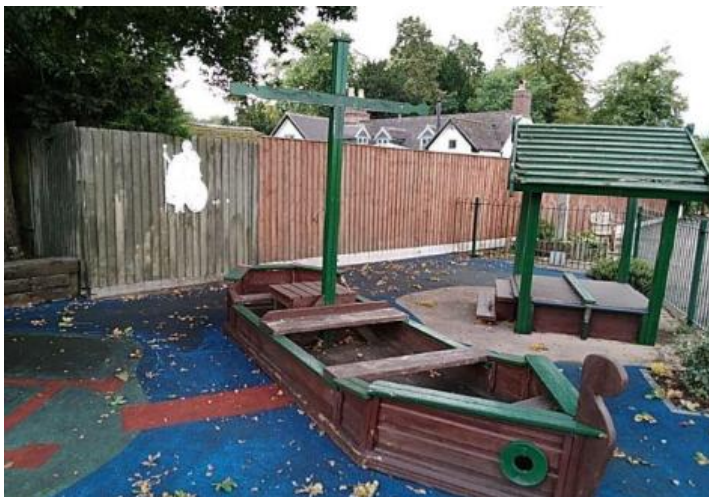
Finding: A number of fixing(s) have worked loose

Action: Secure all loose fixings

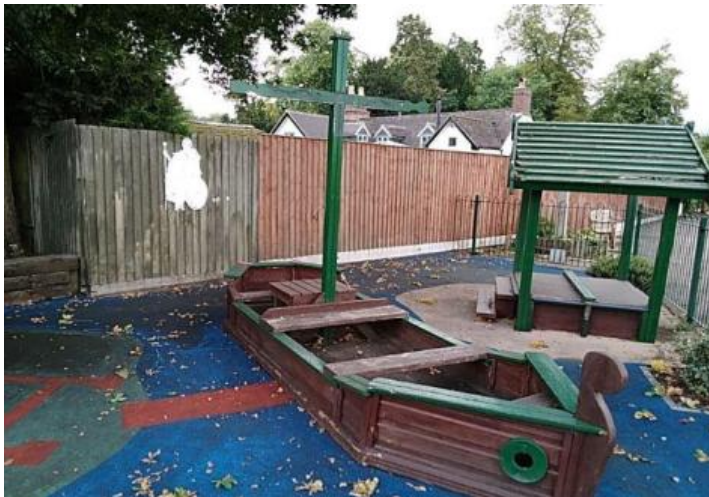
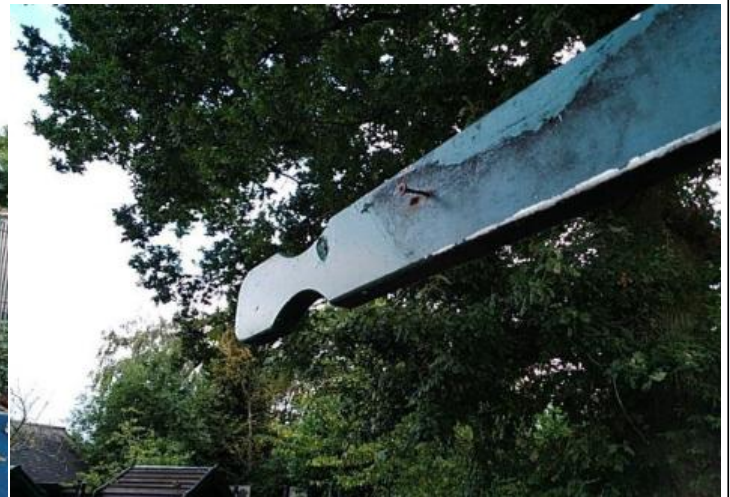
Finding: There are projecting screw ends present

Action: Remove and provide more appropriate fixings if required

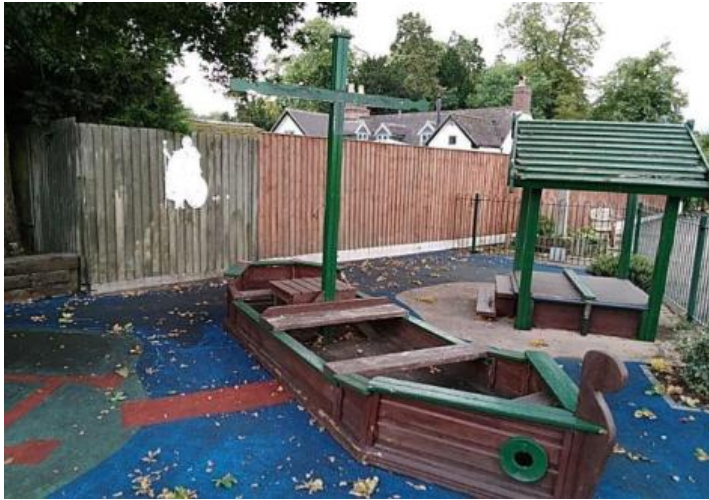
Finding: This item of equipment relies on a single post, or a line of posts, for stability and extra care needs to be taken with equipment of this nature to avoid the potential for catastrophic failure
Action: Ensure that regular detailed inspections are undertaken to assess for rot, corrosion and general stability
