the **play inspection** company

Annual Inspection

Lichfield District Council

Elford Jubilee Memorial Playground

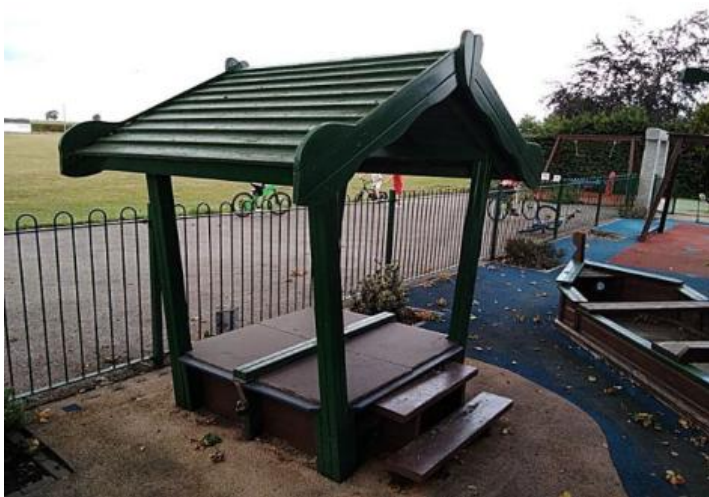
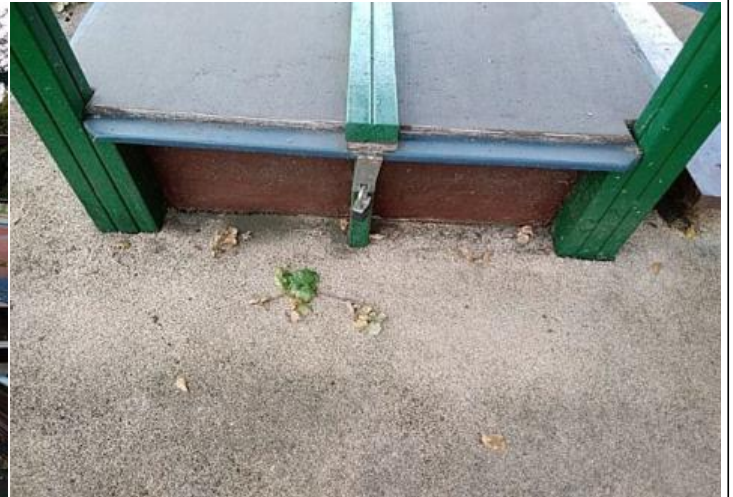
Finding: This item of equipment was not assessed during this inspection as the item was locked
Action: Arrange inspection of the item when it is available

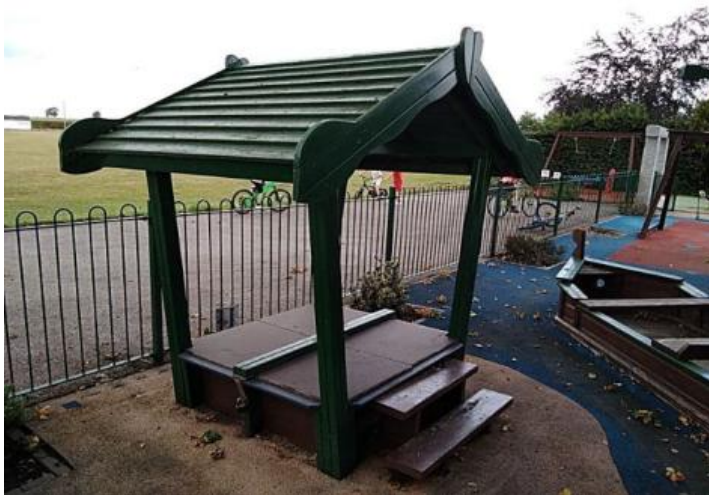
Finding: The fence forms a hard object within the impact area of the equipment in contravention of the requirements of BS EN 1176 Part 1

Action: Monitor - No remedial work recommended

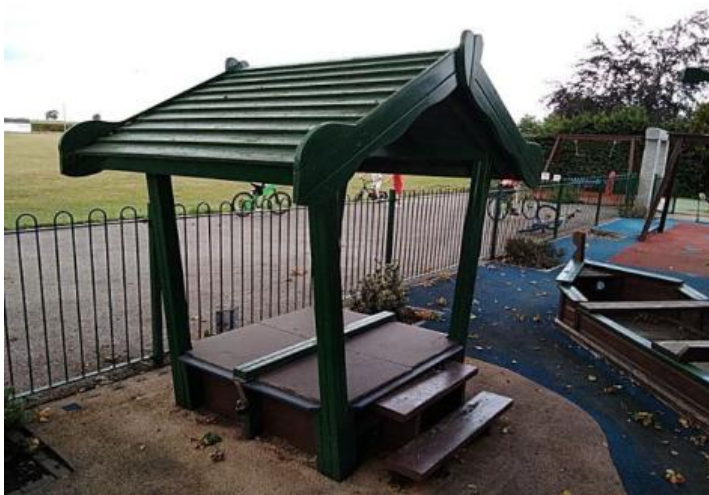
Finding: The boat forms a hard object within the impact area of the equipment in contravention of the requirements of BS EN 1176 Part 1

Action: Monitor - No remedial work recommended

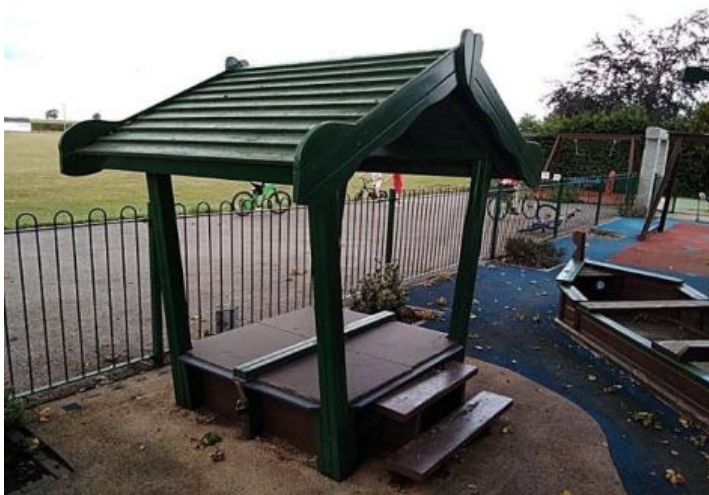
Finding: A number of fixing(s) have worked loose

Action: Secure all loose fixings

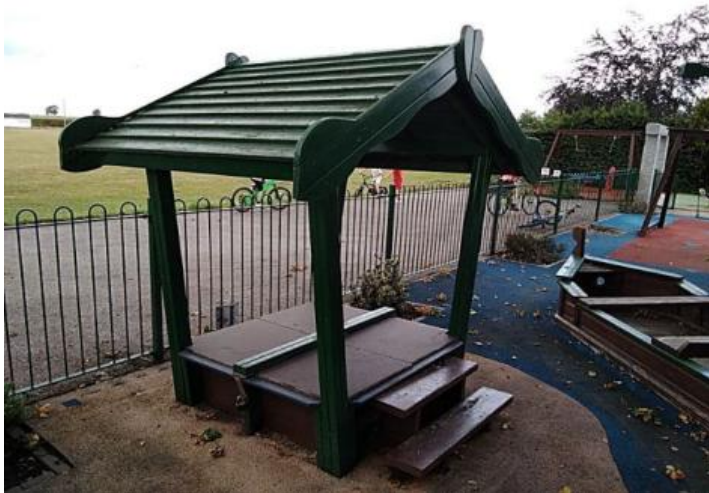
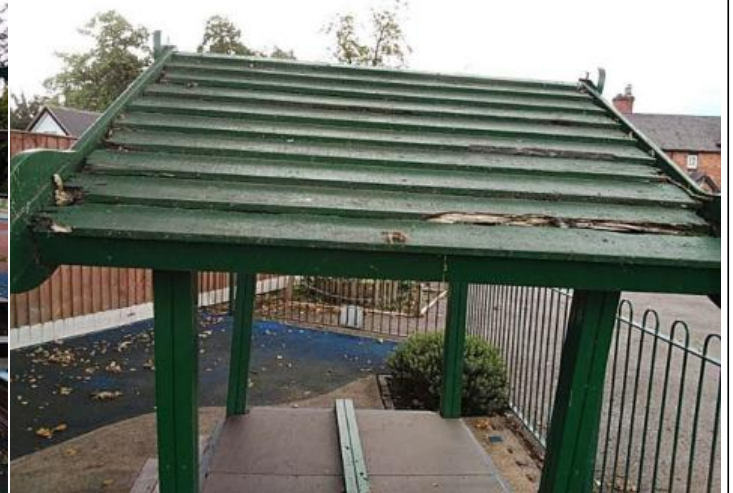
Finding: There are areas or parts of the timber roof on the structure that have rotted

Action: Replace all affected timbers

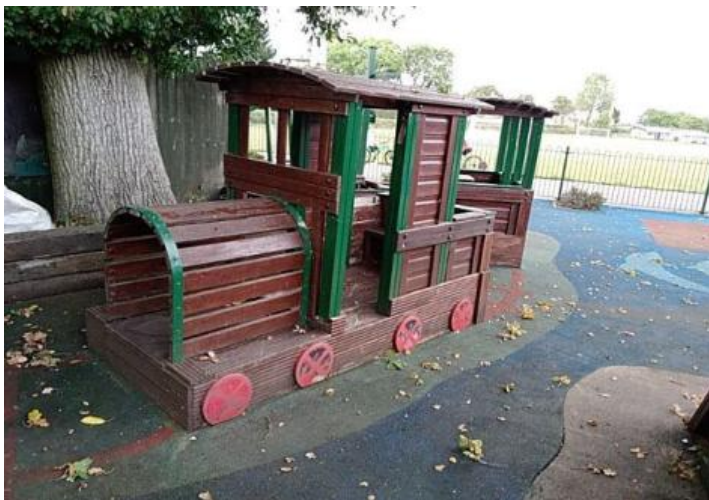
Finding: The sleepers form a hard object within the impact area of the equipment in contravention of the requirements of BS EN 1176 Part 1

Action: Monitor - No remedial work recommended

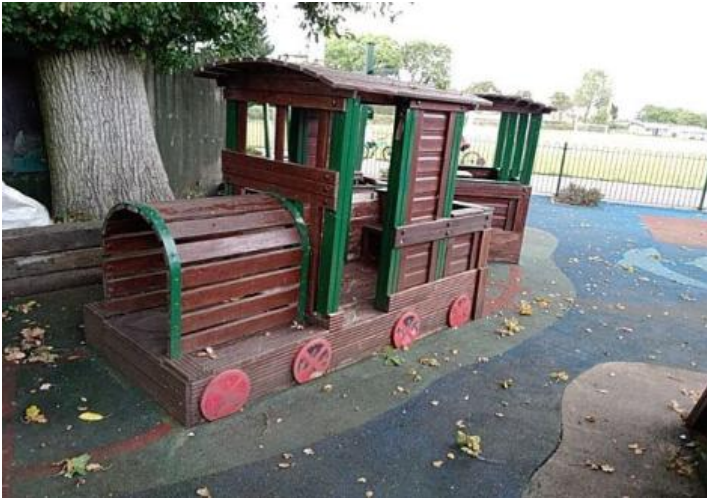
Finding: The design of the barriers encourages standing or sitting and fails the requirements of BS EN 1176
Action: Monitor - No remedial work recommended

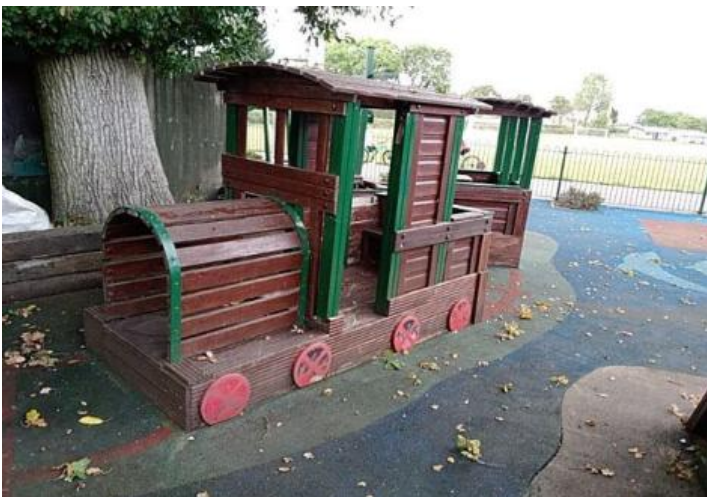
Finding: A number of fixing(s) have worked loose
Action: Secure all loose fixings

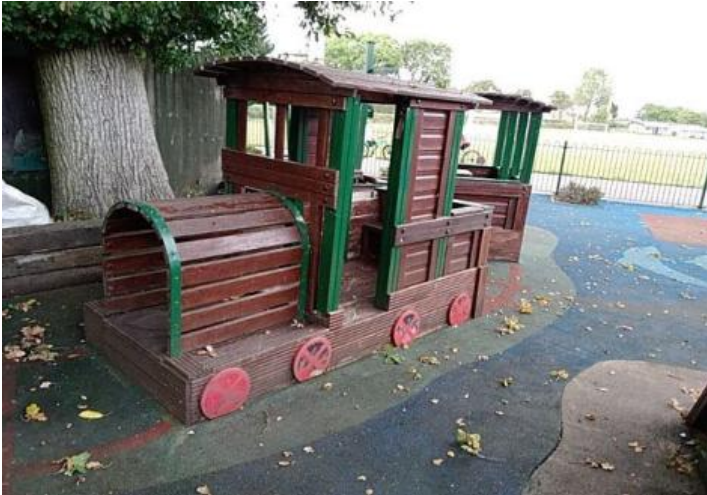
Finding: There are areas or parts of the timber on the structure that have rotted

Action: Replace all affected timbers

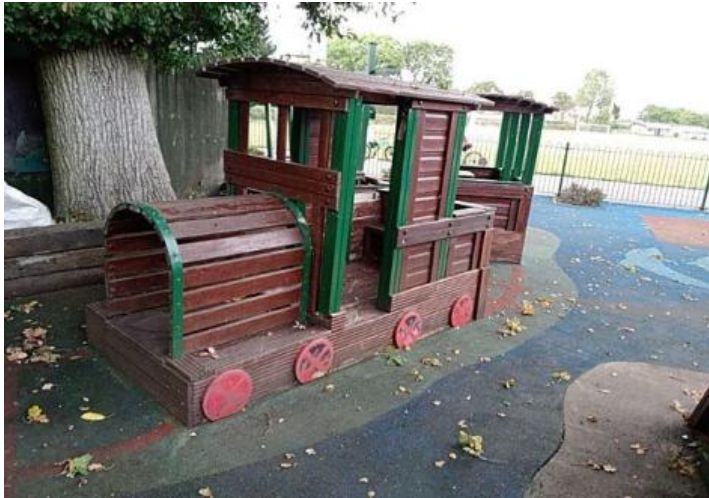
Finding: The item has exposed edges and corners with a radius of less than 3mm and fails the requirements of BS EN 1176
Action: Provide a 3mm radius to all exposed edges and corners

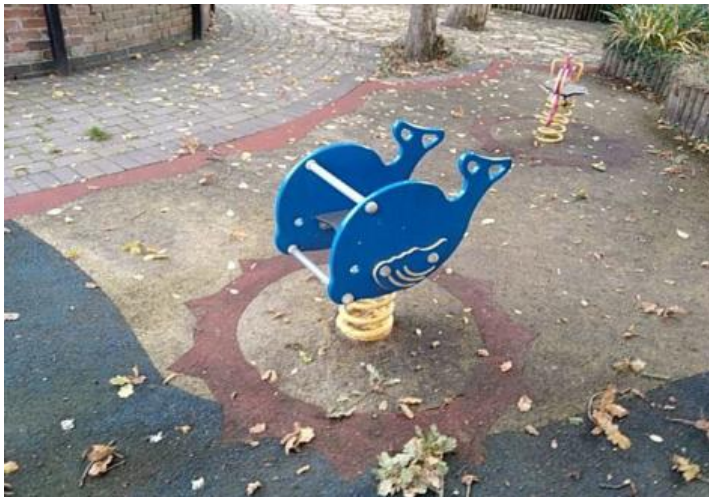
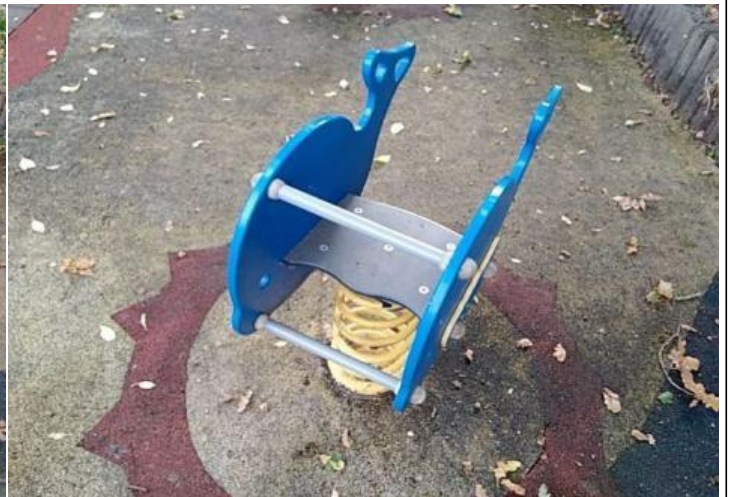
Finding: The Handgrips/Footrests rotate and may cause an unexpected movement for the user
Action: Secure Handgrips/Footrests to prevent rotation.

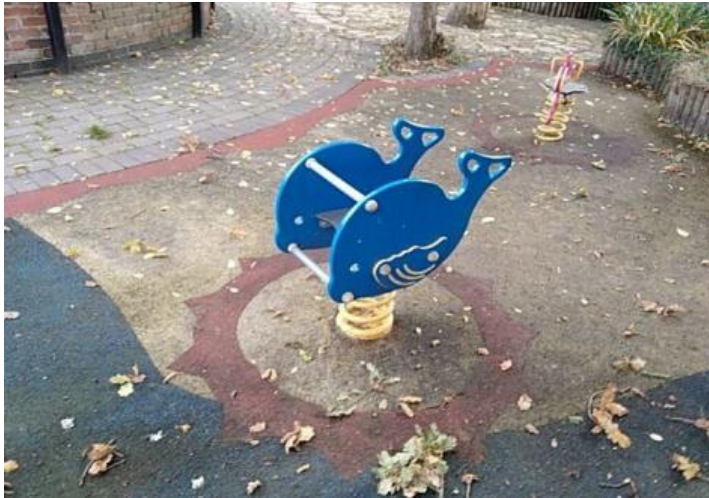
Finding: The paintwork on the spring has been damaged or worn exposing the metal underneath which is rusting
Action: Treat any rusting components and repaint

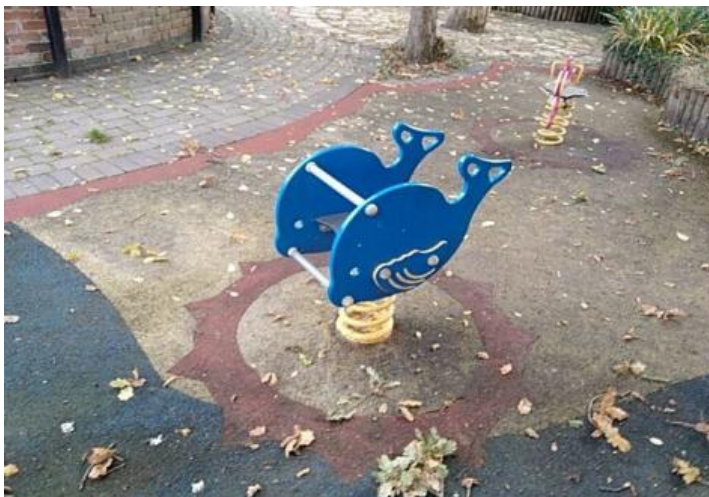
Finding: There is algae or moss growth on the surface resulting in slippery conditions
Action: Clean and treat appropriately

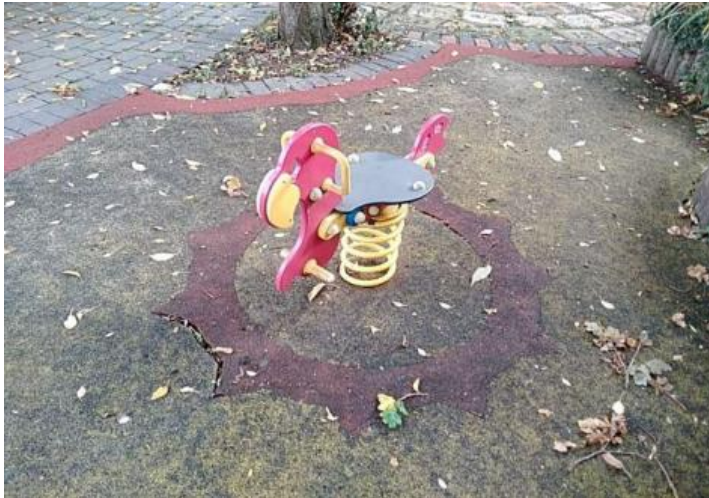
Finding: There are gaps opening between the surfacing and the edging surround or between the joints in the surfacing
Action: Monitor for any further deterioration and repair as required

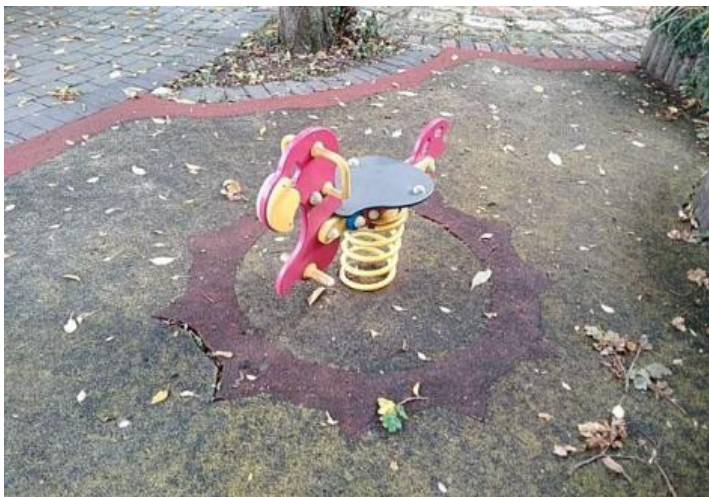
Finding: There is algae or moss growth on the surface resulting in slippery conditions
Action: Clean and treat appropriately

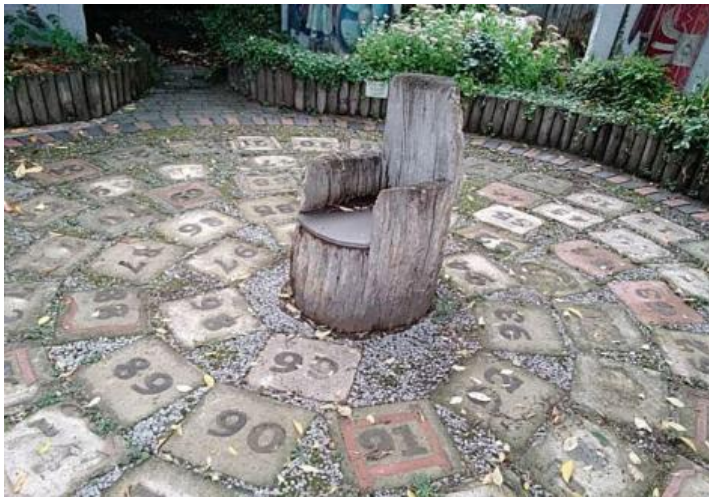
Finding: There are trip hazards at the edges of the surface
Action: Reinstate surrounding surface levels to remove the trip points

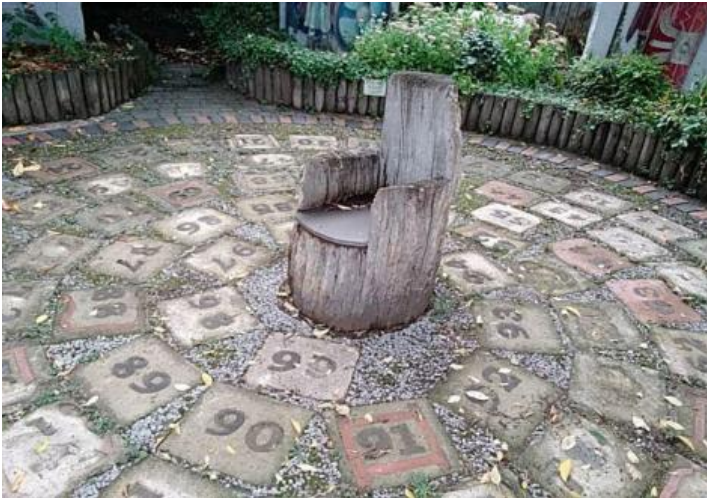
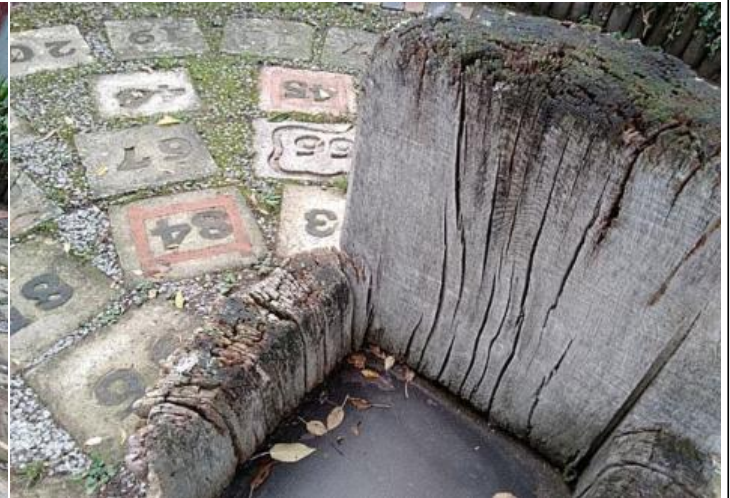
Finding: Parts of the timber are rough or splintered

Action: Remove all rough or sharp edges

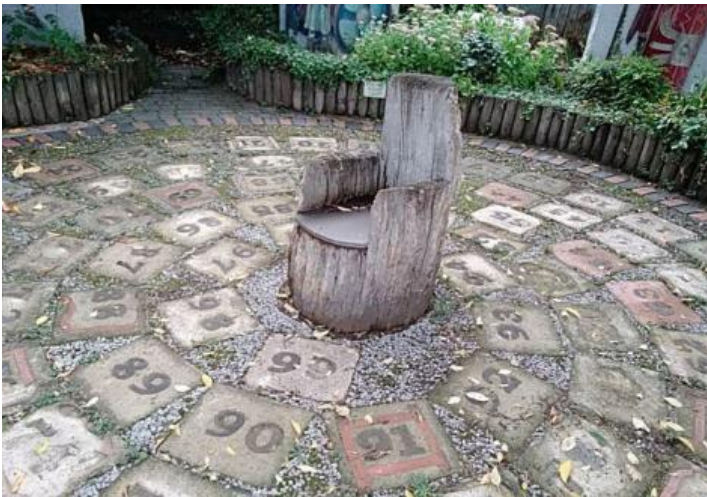
Finding: The item is loose in its foundations

Action: Reinstall item to secure

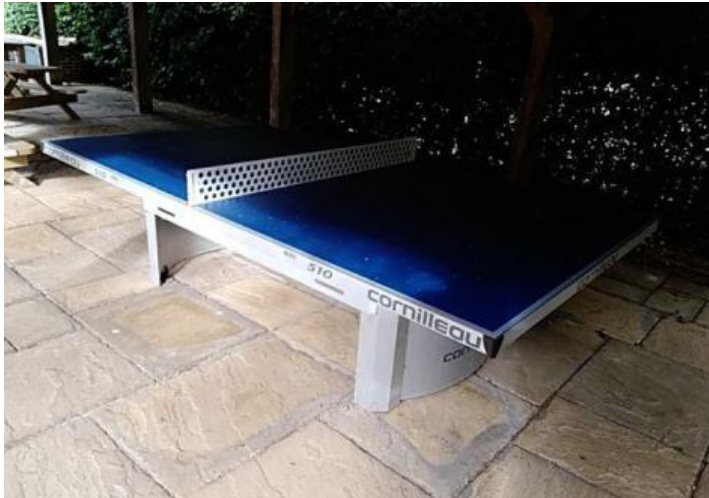
Finding: The slab is lifting at the edges and creating trip points

Action: Repair surfacing to remove trip points

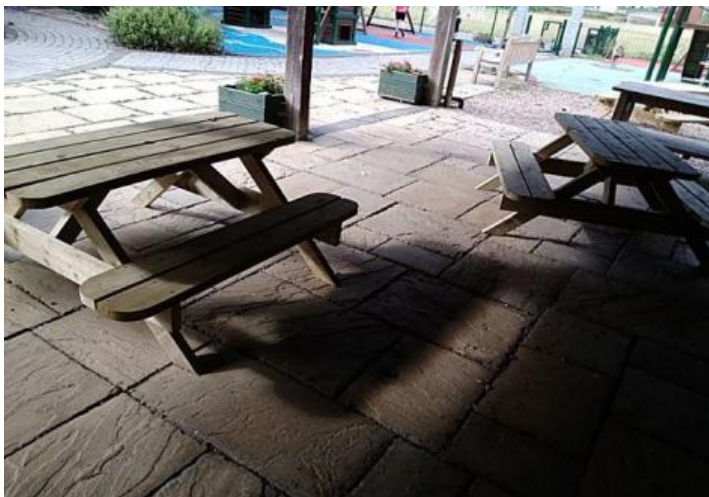
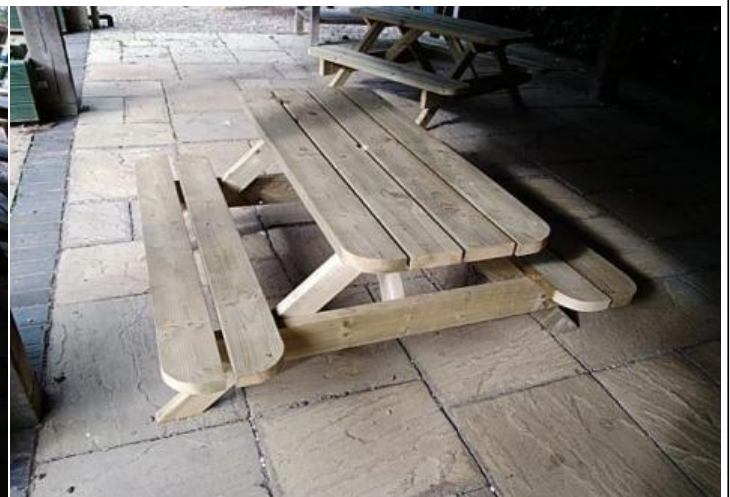
Finding: The bench is not securely fixed to the surface and there is some possibility of the item tipping or rolling over

Action: Secure the bench to the ground

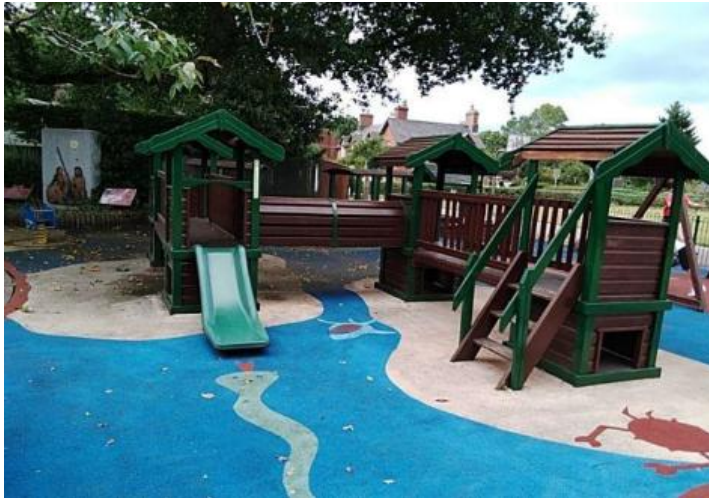
Finding: There is algae or moss growth on the surface resulting in slippery conditions

Action: Clean and treat appropriately

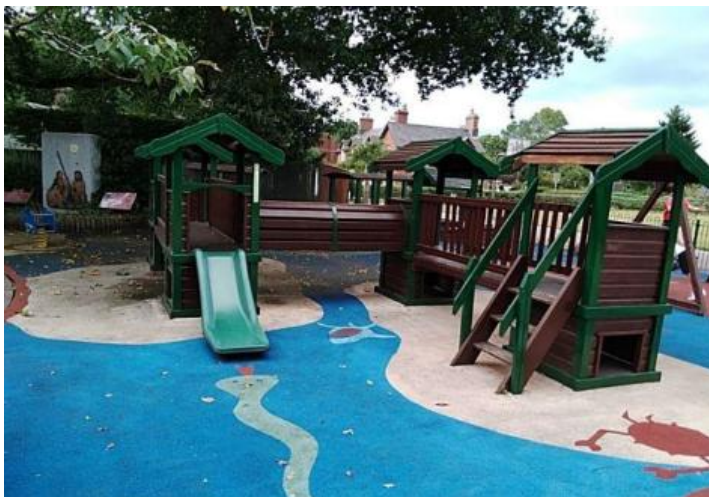
Finding: The surface has subsided in some areas
Action: Monitor for any further deterioration and repair as required

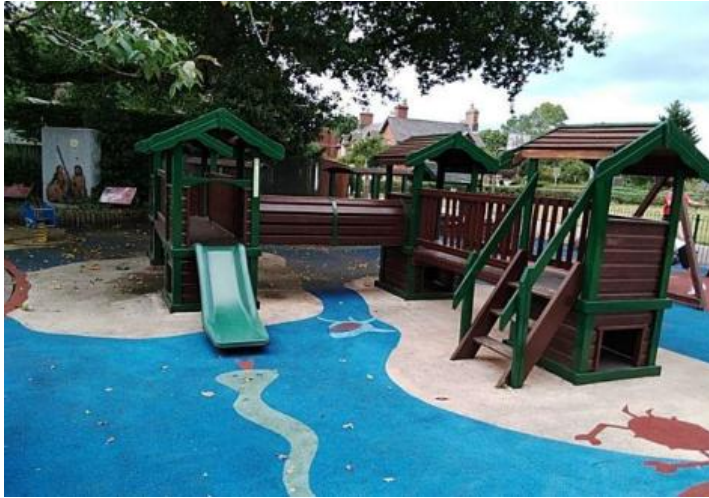
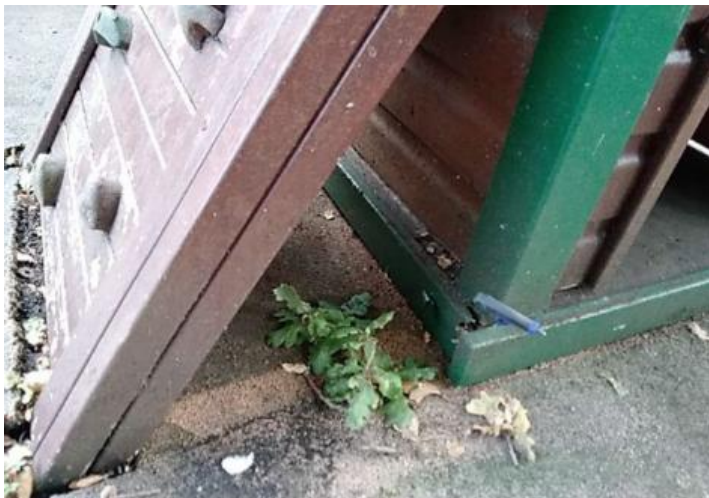
Finding: There are areas or parts of the timber on the structure that have rotted

Action: Replace all affected timbers

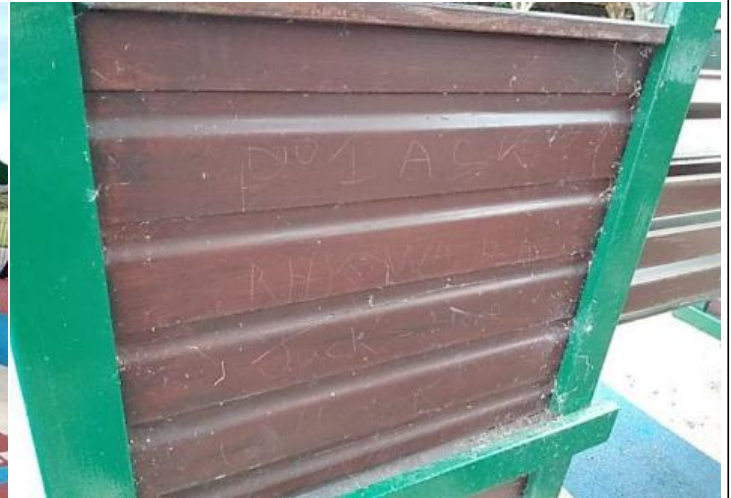
Finding: There is some graffiti present

Action: Remove the graffiti

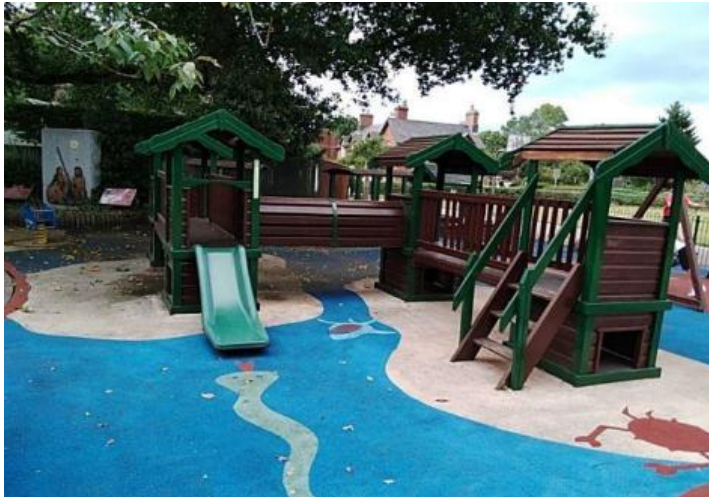
Finding: The fireman's pole is less than 350mm from the platform and fails to meet the recommendations of BS EN 1176 Part 1

Action: Monitor - no remedial action recommended

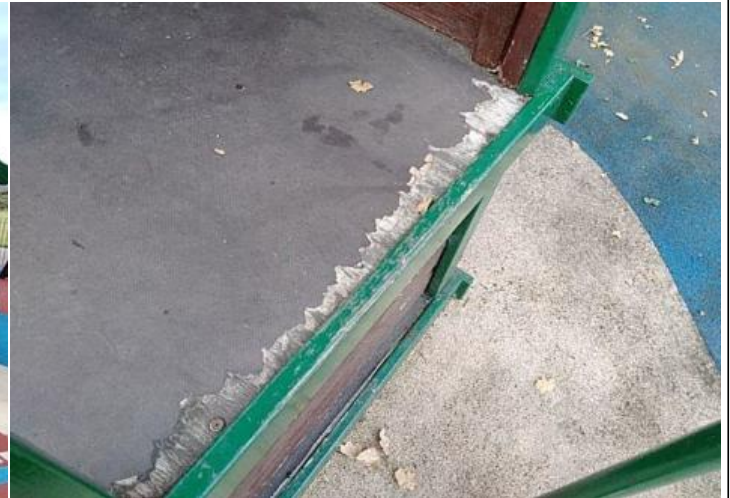
Finding: The plywood has delaminated in some places

Action: Remove all rough or splintered edges.

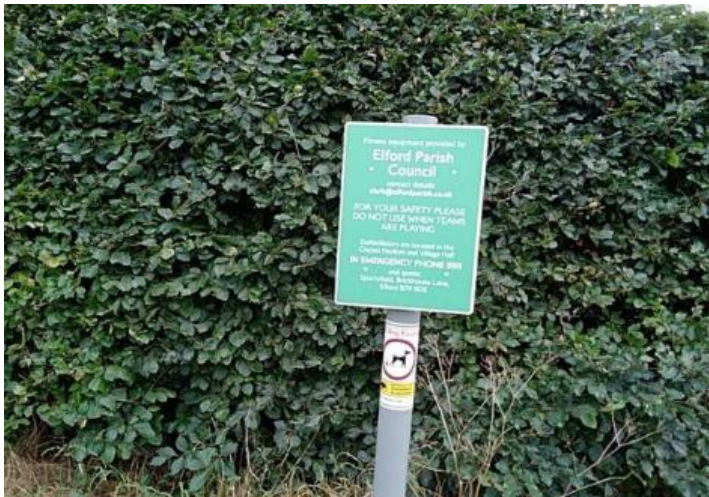
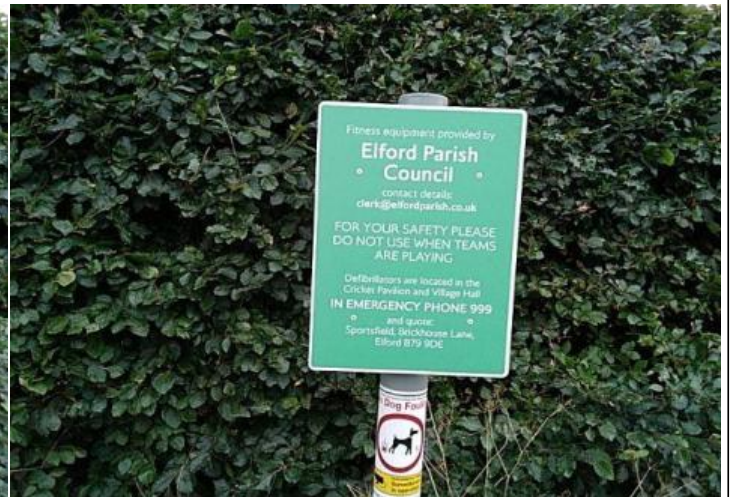
Finding: Signage should be provided for the outdoor fitness equipment in accordance with the requirements of BS EN 16630, key requirements of the sign include, but are not limited to, intended users, medical safety and emergency contact details

Action: Provide appropriate signage

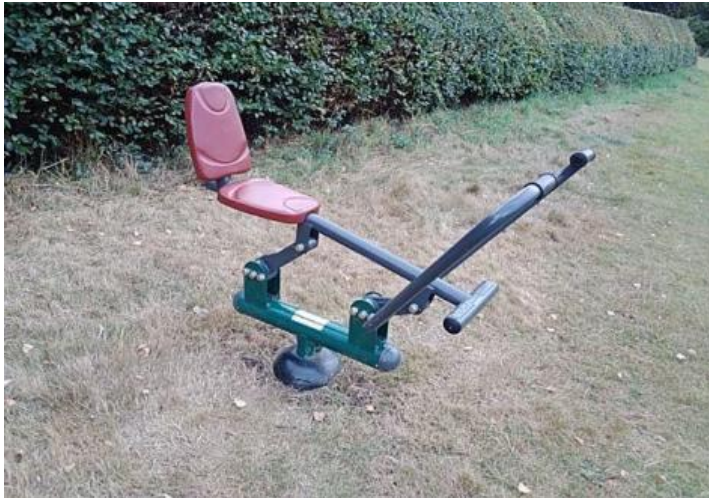
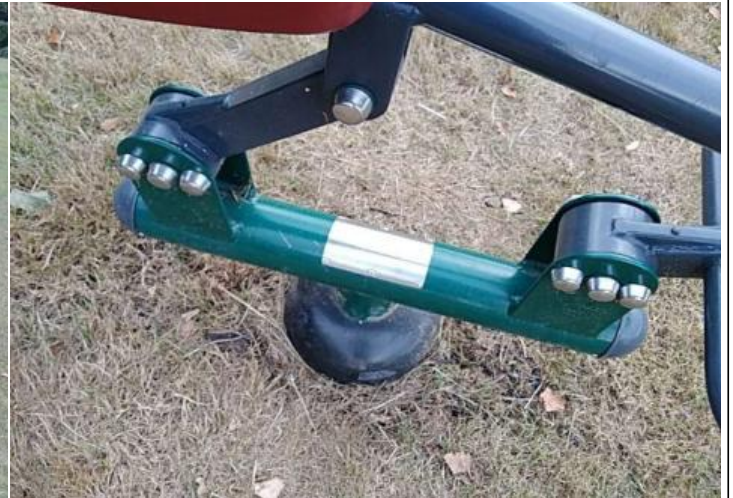
Finding: There is no clear instruction label provided; an instruction label should be provided with each item of equipment in accordance with the requirements of BS EN 16630

Action: Provide appropriate instruction label/s

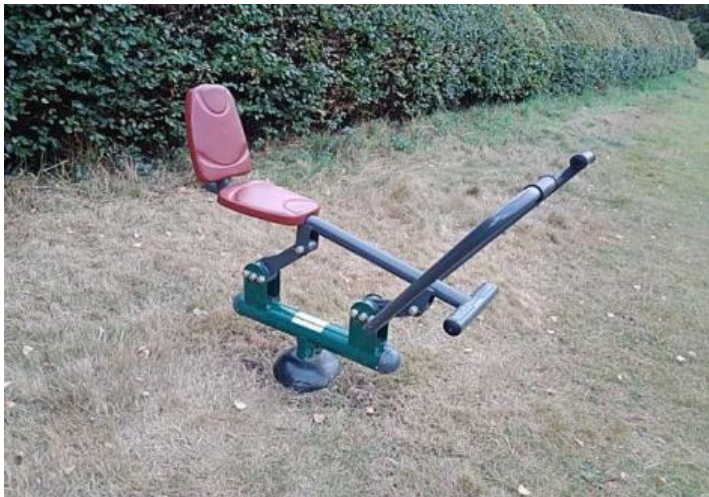
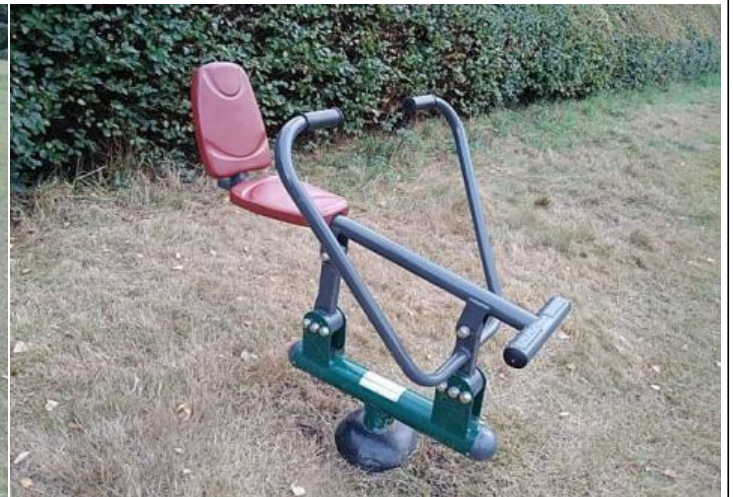
Finding: BS EN 16630 - 4.3.1 states that fitness equipment shall be designed so when at rest, the equipment shall automatically adjust so that the equipment is ready for the next user

Action: Service the item

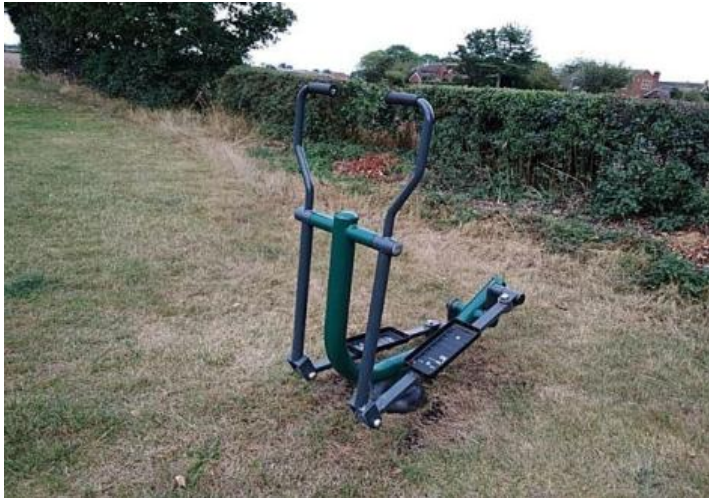
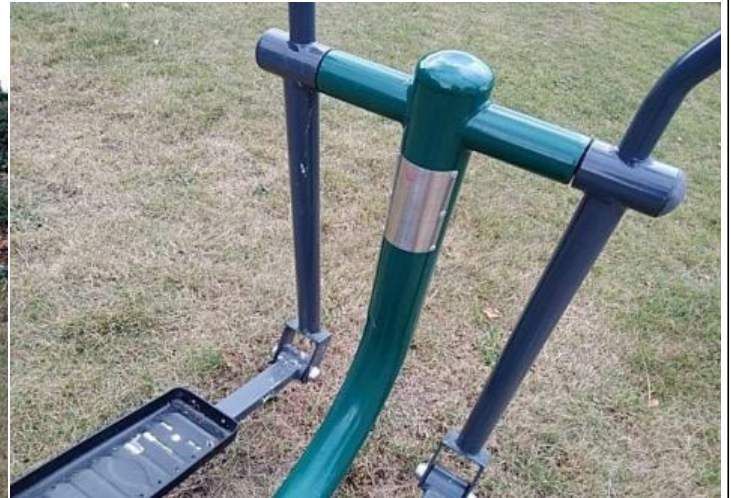
Finding: There is no clear instruction label provided; an instruction label should be provided with each item of equipment in accordance with the requirements of BS EN 16630

Action: Provide appropriate instruction label/s

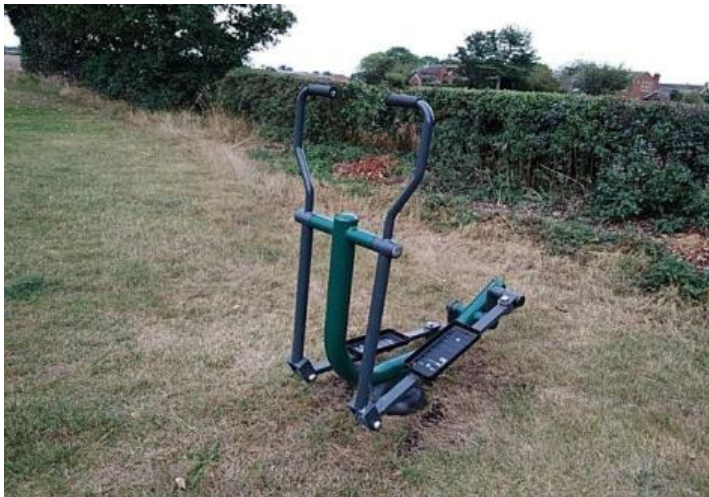
Finding: The distance between the underside of the item and the ground is less than the 110mm required by BS EN 16630

Action: Monitor - No remedial work recommended

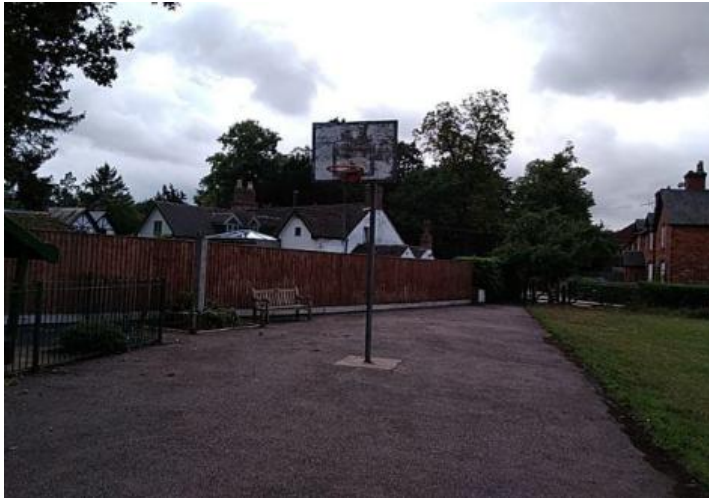
Finding: There is some damage to the chain net

Action: Replace or repair as required

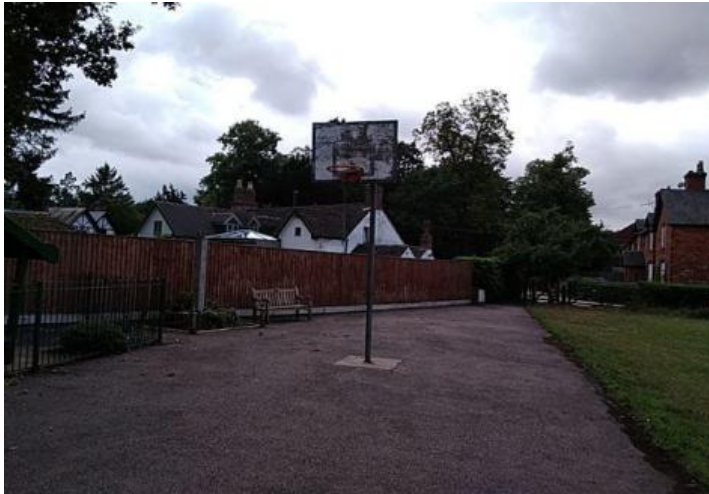
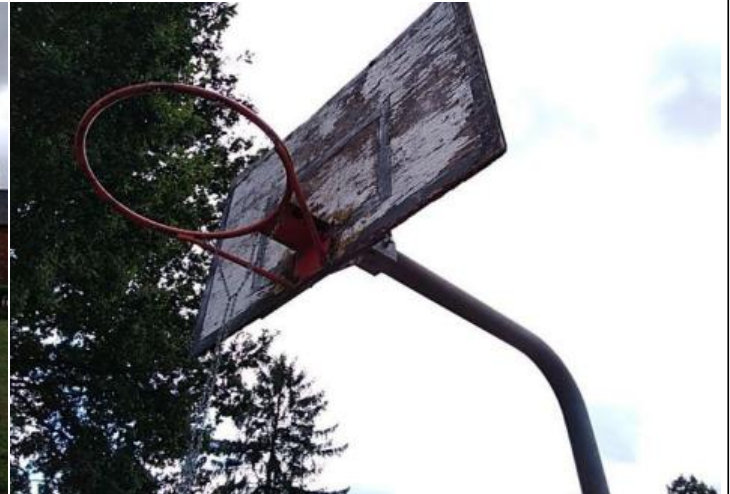
Item: Multi Use Games Area - Basketball Post
Manufacturer: Not Identified

Finding: The backboard is damaged

Action: Monitor for any further deterioration and repair as required

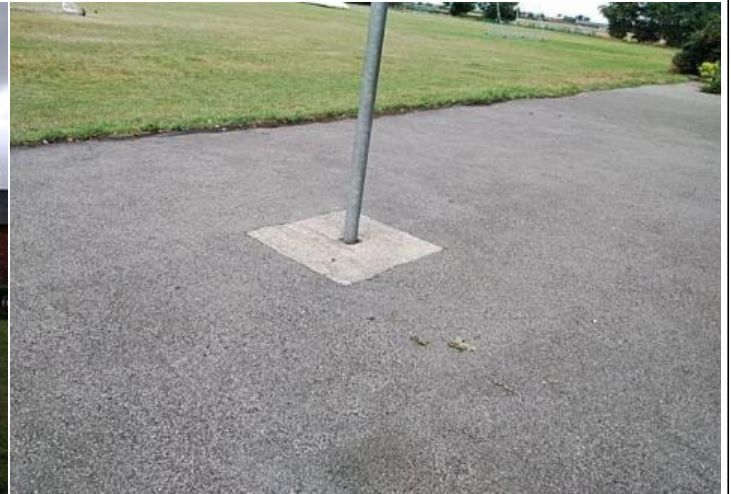
Item: Multi Use Games Area - Basketball Post
Manufacturer: Not Identified

Finding: The item is slightly loose in its foundations

Action: Monitor for any further deterioration and repair as required
